Panama Canal Commission  
Engineering Division  
Geotechnical Branch

THE RISK OF LANDSLIDES  
IN GAILLARD CUT

Luis D. Alfaro

October 20, 1988

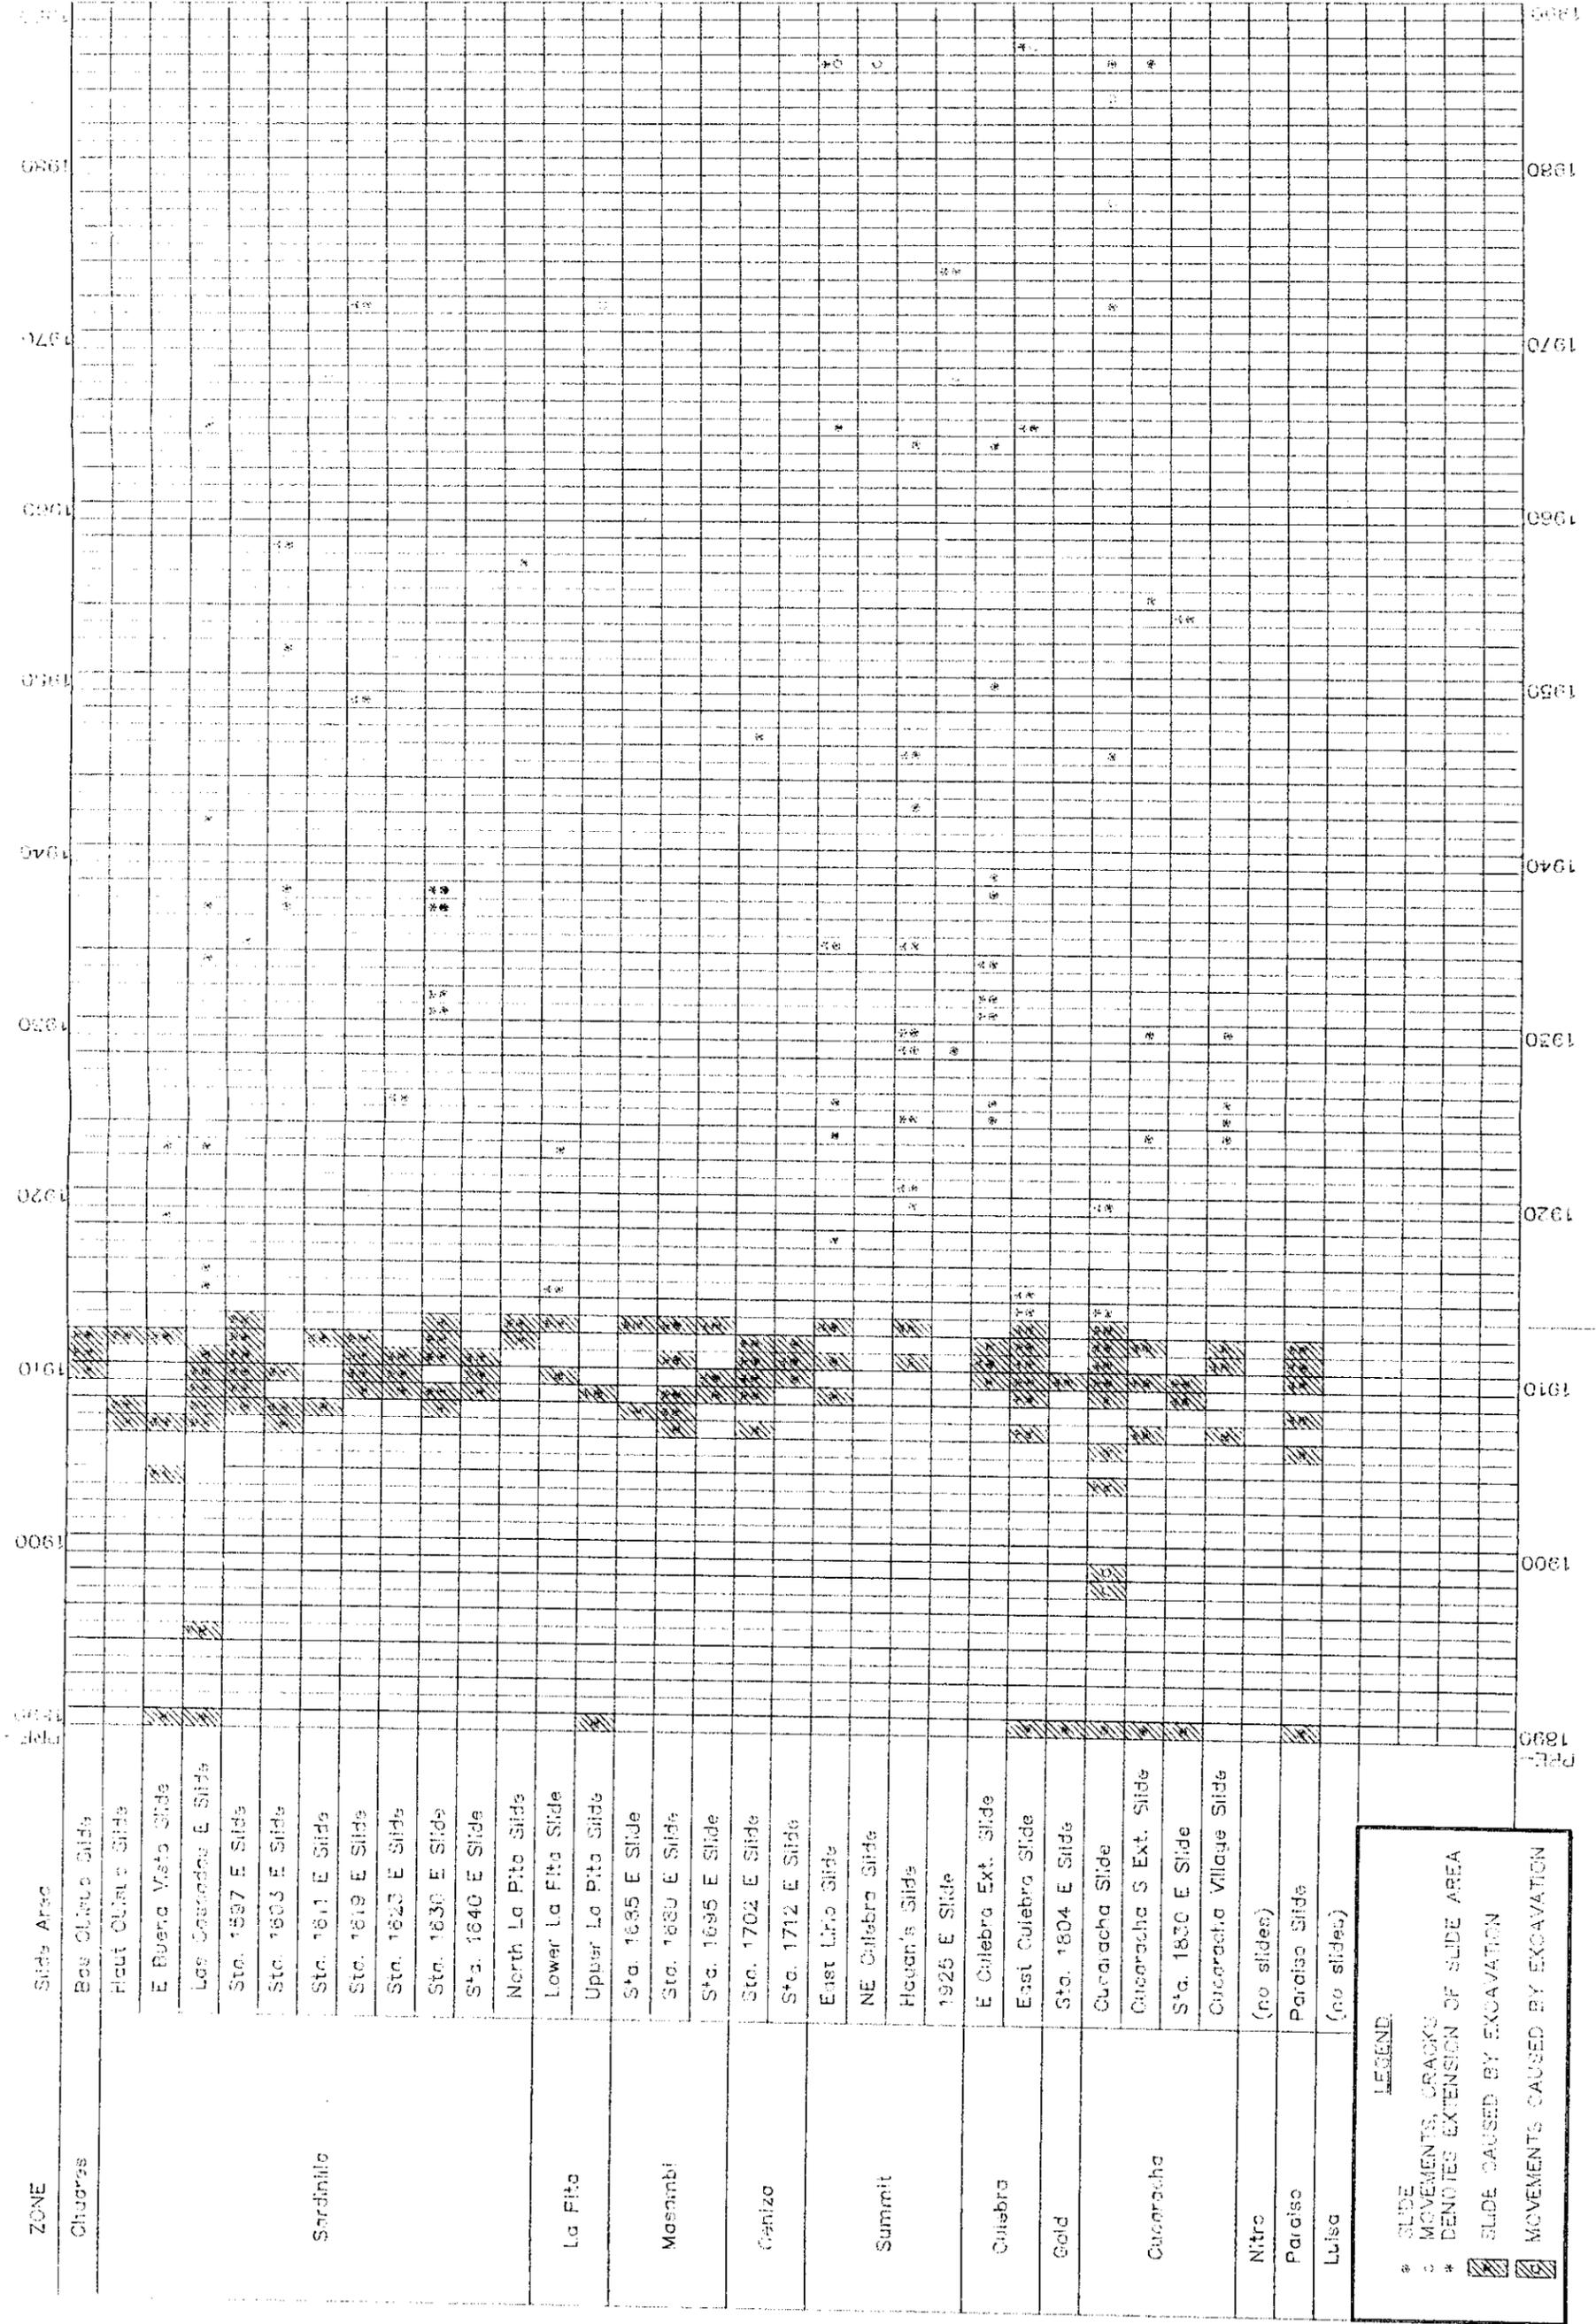
Figure 2

Figures 2 and 3 provide an additional distinction between slide events: those which were fully developed slides and those which were incipient slides (manifested by surface cracks, and movements). In recent years most of the incipient slides have been detected by means of instrumentation (of the Landslide Control Program). However, in a number of cases the potential instabilities have been first discovered through field inspections. Surface cracks, tilted posts, damaged penetration roads, and other similar manifestations of instability have been detected prior to the examination of the surveillance program. Sometimes, these observations have discovered

The assessment of risks requires a qualitative understanding of the causes of failure. By viewing the information contained in figures 2 and 3 on the slide history of Gaillard Cut, valuable insights may be gained in understanding the nature of the landslide problem. Consider the following observations:

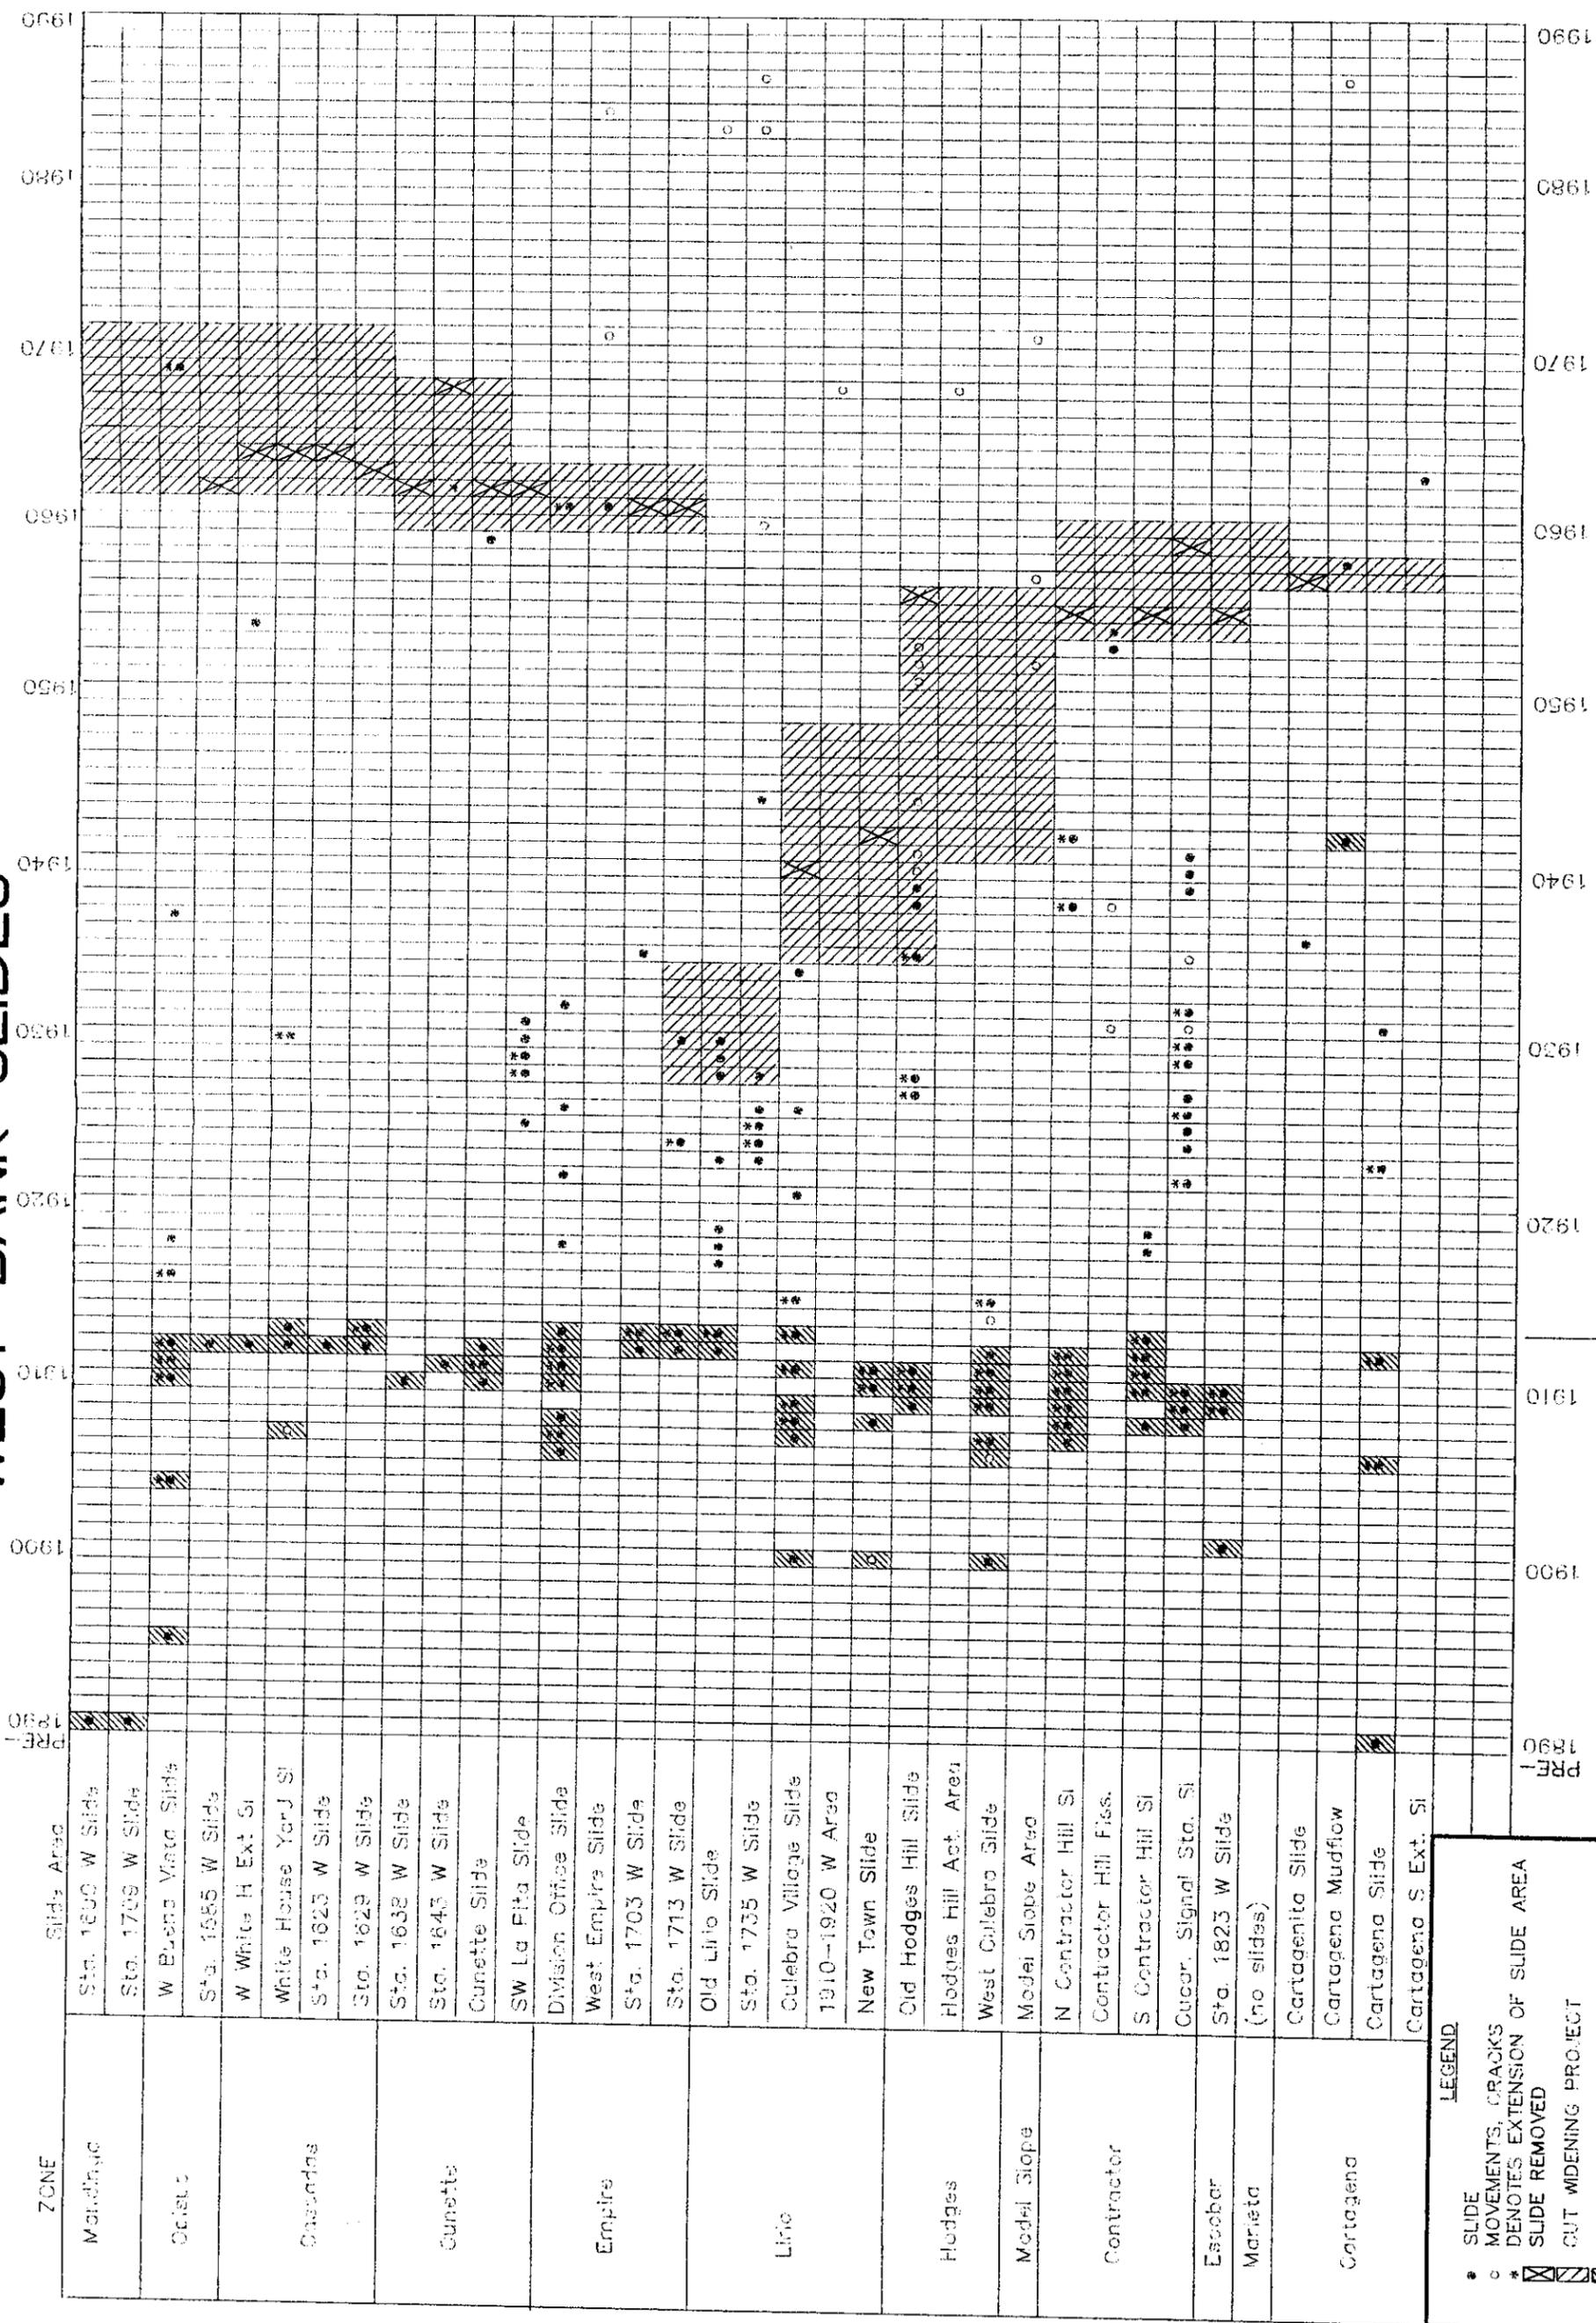
Figure 3

The periods of Canal excavation are noted in each figure. Most of the slides coincide with this activity. The Canal was gradually widened (from 300 feet to 500 feet) by excavation along the West Bank. The progress of this excavation can be traced in Figure 3. Many post-construction instabilities in the West Bank were associated with this project.

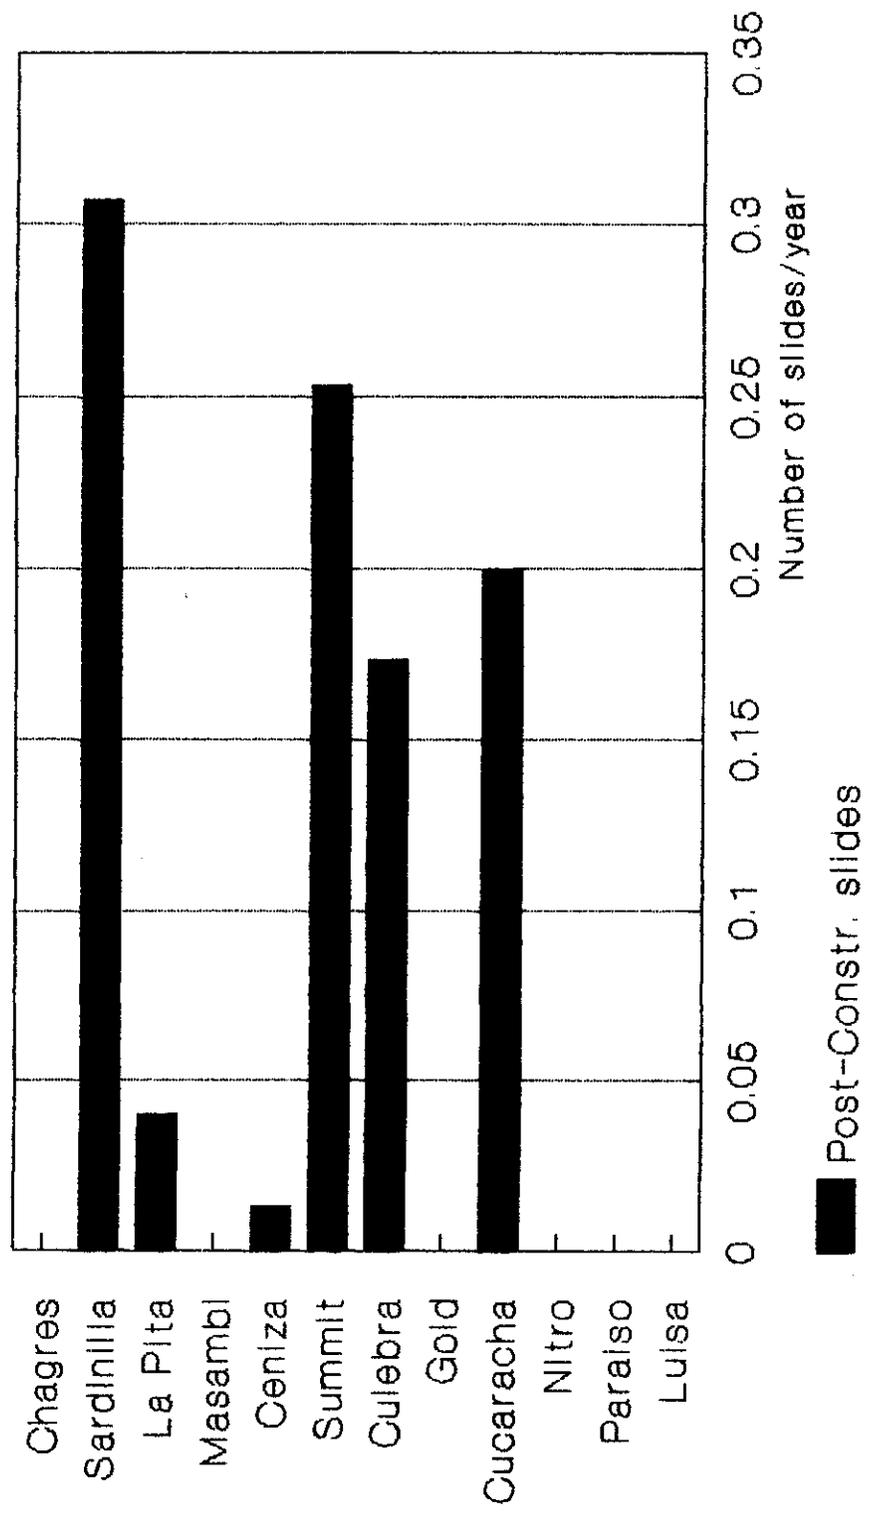
Figure 9

Table 4, and Figures 9 and 10 present the post-construction/post-widening rates of failure in the East Bank and West Bank, respectively. These can be used as adequate estimates of the probabilities of failure for each zone.

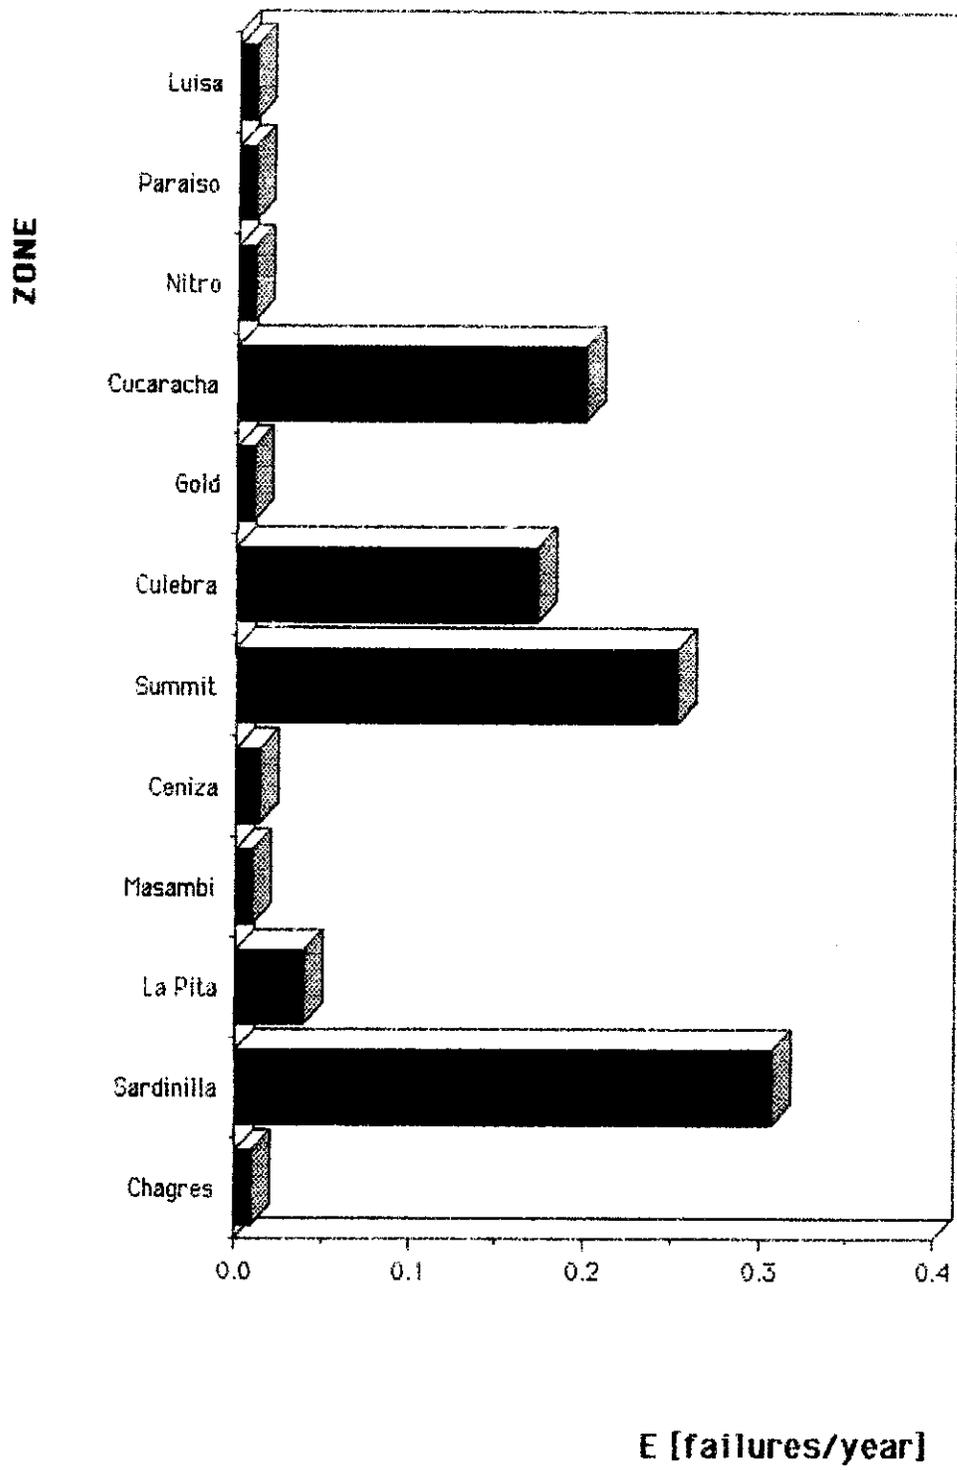
**Figure 11: Estimated Annual Probabilities of Failure (East Bank)**

all zones (Figures 11 and 12). Although the period of time after the Cut Widening Project is variable for the West Bank zones, and in all cases less than a century, the same default value of risk ( $pf=0.01$ ) will be maintained for slopes that have not manifested post-widening landslide activity. There are several reasons to support this decision. First, most slides which were active during the pre-widening period, were removed during the widening. Second, this project was carried out with a technological knowledge far superior to that which existed during Canal construction. The designs for the Cut Widening had a rational basis. Third, the behavior of these slopes, that have had no post-widening activity, seems very similar to that of east bank slopes that have been quiescent since Canal construction. Hence, the writer feels that the stated default value of risk is a better representation of the state of these slopes than a higher risk level that corresponds, say to the inverse of the post-widening periods for each case.

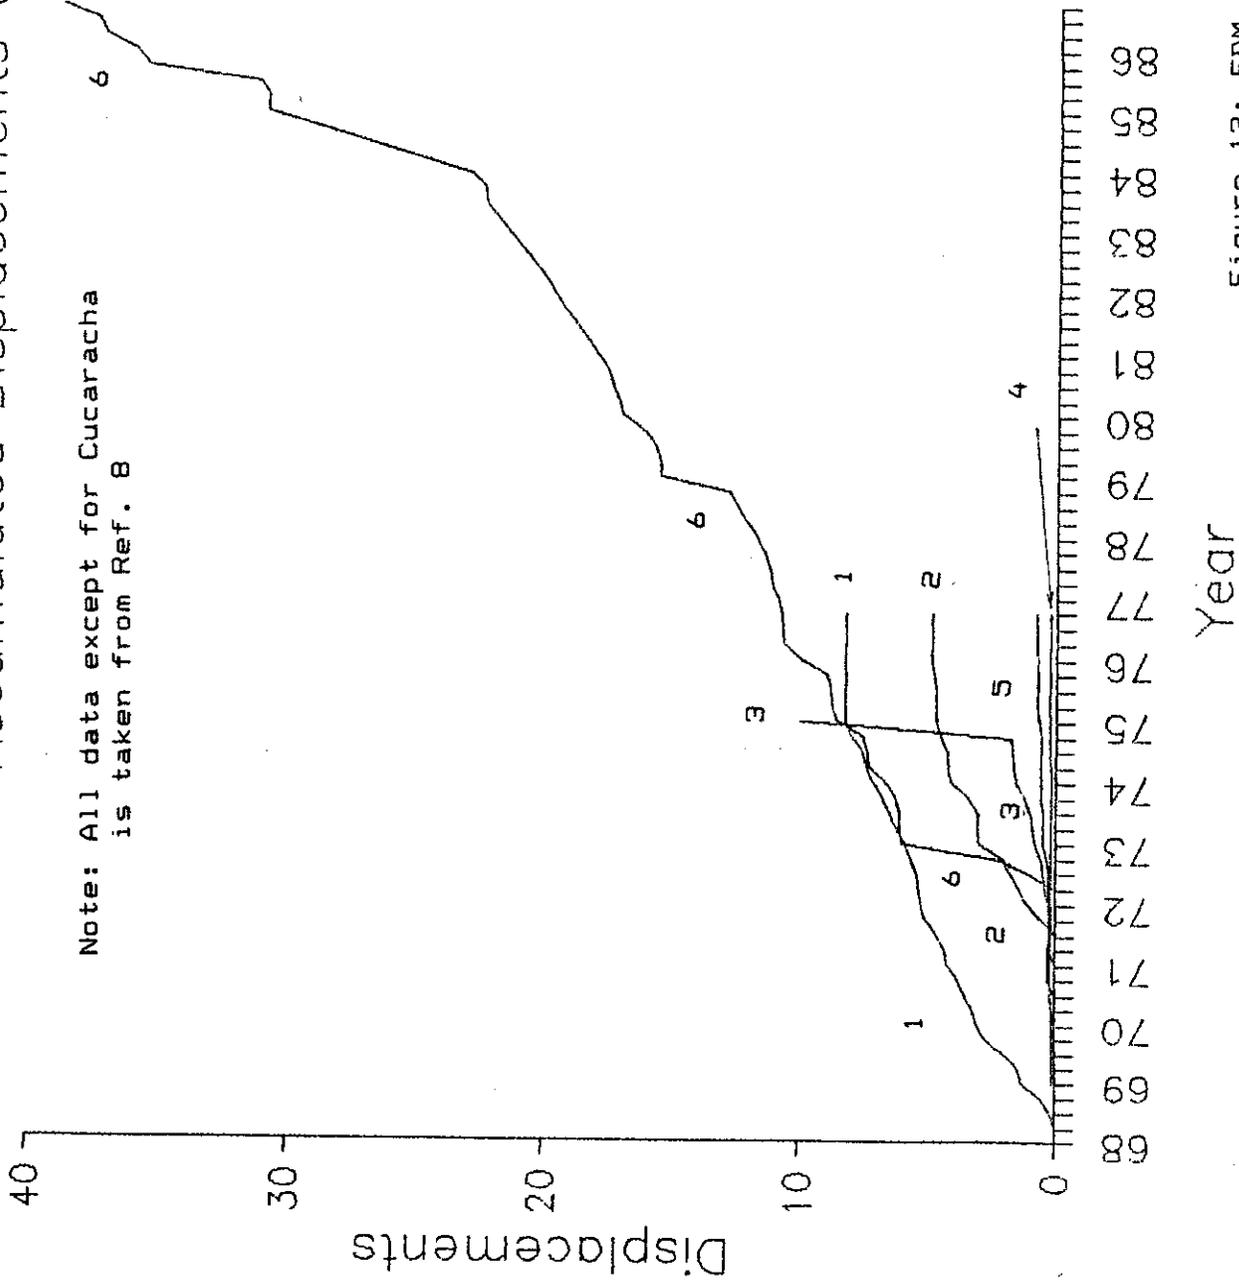
Figure 13: EDM motion vectors for selected slopes

Figure 13 shows the movements that took place prior to a slide in selected slopes (Ref. 8). The figure shows that the magnitude of the movements that lead to a fully developed failure are very dissimilar from one slope to another. No specific "signature" associated with a fully developed slide is readily evident. For example, the Cucaracha Slide exhibited much larger movements than the 1925 E Slide before reaching failure.

We can hypothesize a mechanism which is consistent with much of the observed information. During critical periods of high precipitation (Ref. 39), rainfall causes saturation of the potentially unstable mass. This increases its weight significantly and exerts pressures on the sliding mass by filling cracks along its periphery. This overstresses the materials along the slip surface, causing in many cases strain-softening. This in turn manifests itself on the ground surface as movements. Continued movements of a slope (even if at a constant rate) should suggest that remedial measures be implemented promptly. This represents a change with respect to our current practice that recommends remedial measures only when the rate of movements increases continuously.

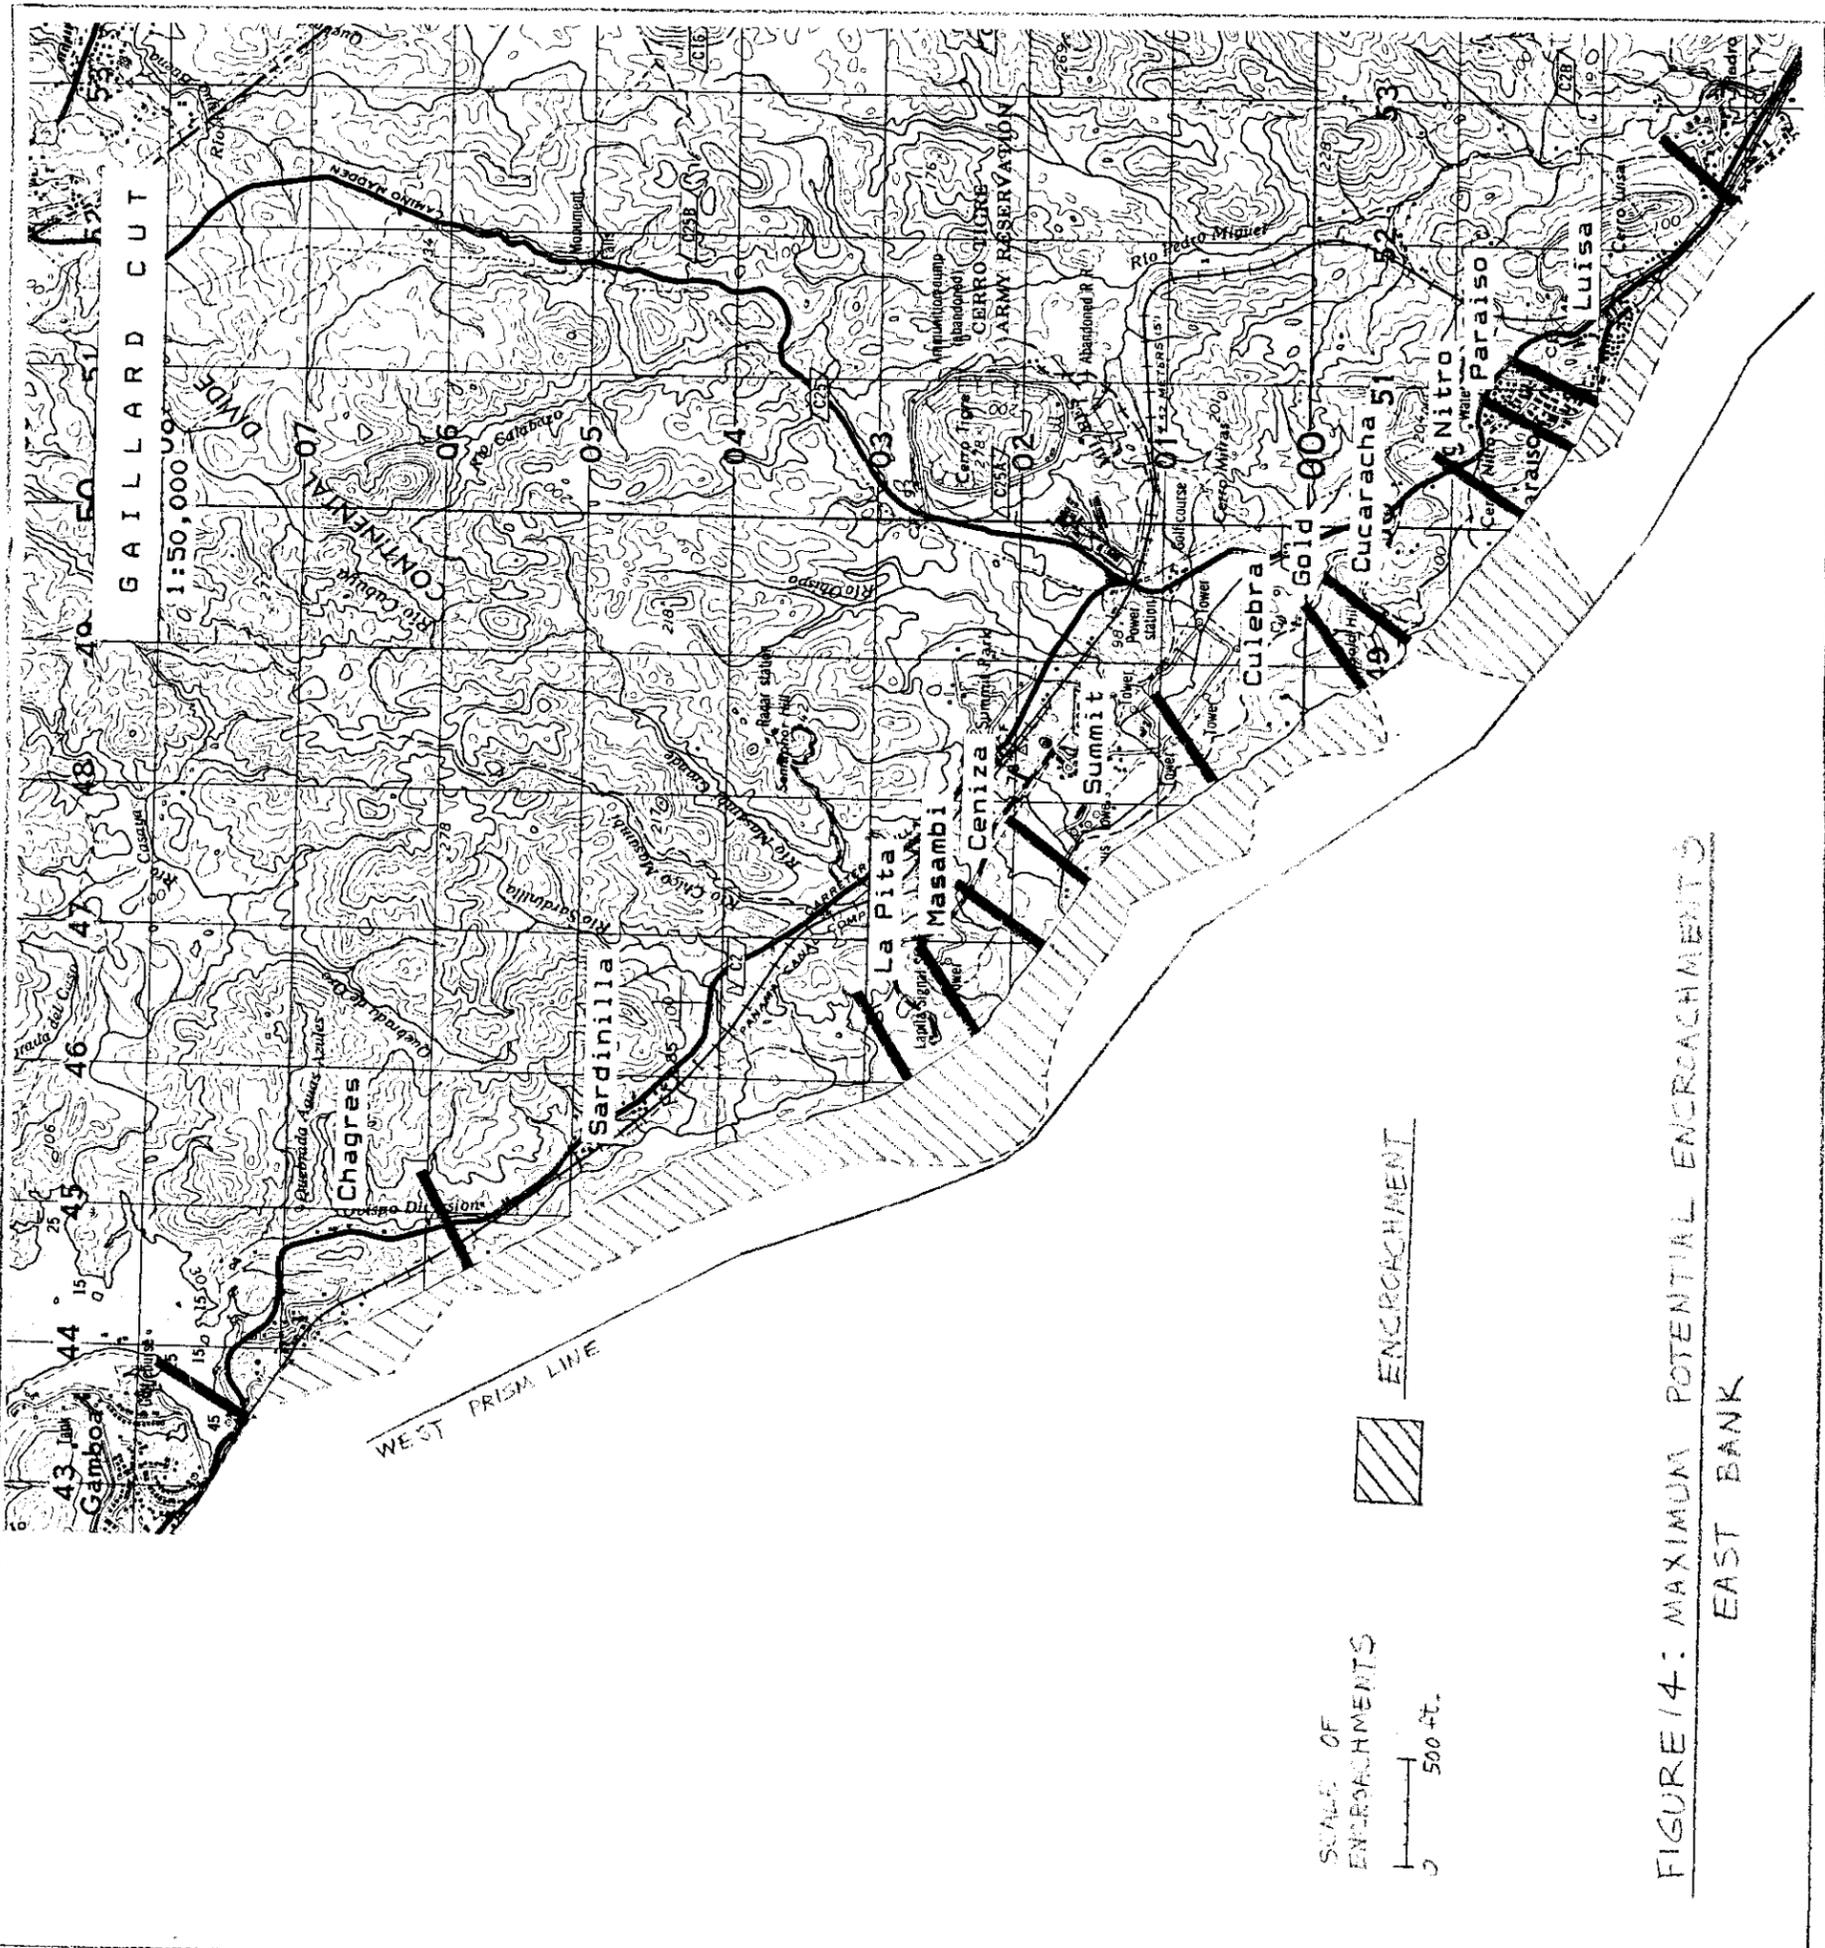
FIGURE 14: MAXIMUM POTENTIAL ENCROACHMENTS  
EAST BANK

Table 5 presents a prediction of the greatest potential encroachments in each bank. These are not expected encroachments; just the maximum values predicted by the analysis presented in Section II.C of this report. The regression line in Figures 4 and 5 coincide reasonably well with the criteria proposed by Binger in 1946. However, the upper prediction limits (which are effectively upper bounds to all the observed data contained in Table 3), were used to generate the conservative values of encroachments shown in Table 5. Figures 14 and 15 present a graphic representation of these maximum encroachments in the East and West Banks respectively.

As stated previously, practically all the slide in Gaillard Cut have occurred in weathered tuffs (Cucaracha, Culebra, Gatuncillo, La Boca, and Las Cascadas Formations). Therefore the relationships used to estimate encroachments are only valid in these materials. No slide has occurred in one of the large igneous hills, except for the movements observed in Hodges Hill in 1968. The maximum encroachment predicted for Zone Hodges is
