**CONTRACT CC-3-557**

**Pacific Side Excavation & Dredging  
Material Disposal Alternatives Evaluation**

*Final Report*

**March 2004**

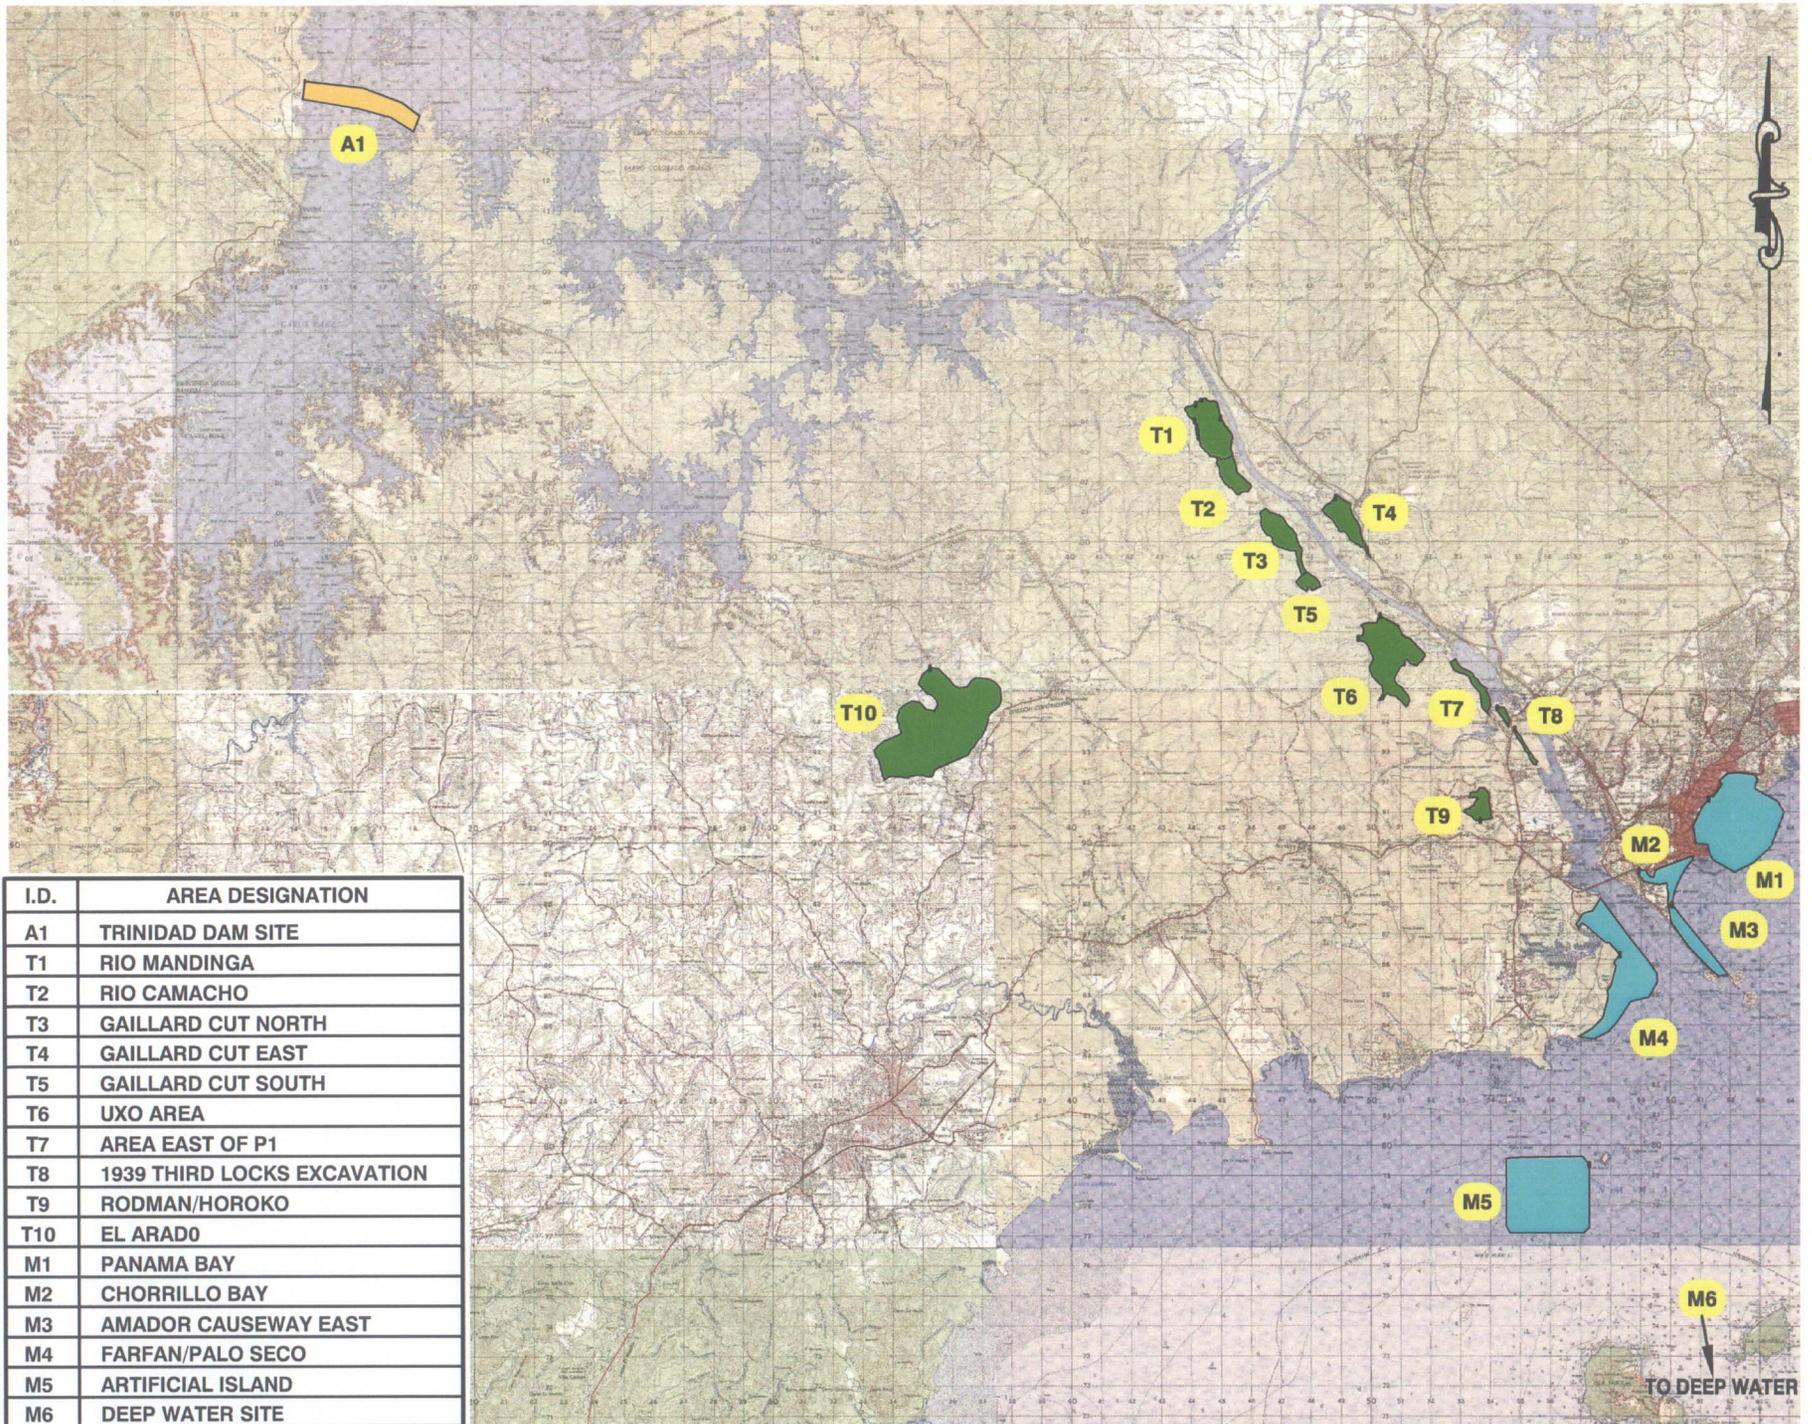
Figure 3-2  
Location of Potential Disposal Sites

I.D.	AREA DESIGNATION
A1	TRINIDAD DAM SITE
T1	RIO MANDINGA
T2	RIO CAMACHO
T3	GAILLARD CUT NORTH
T4	GAILLARD CUT EAST
T5	GAILLARD CUT SOUTH
T6	UXO AREA
T7	AREA EAST OF P1
T8	1939 THIRD LOCKS EXCAVATION
T9	RODMAN/HOROKO
T10	EL ARADO
M1	PANAMA BAY
M2	CHORRILLO BAY
M3	AMADOR CAUSEWAY EAST
M4	FARFAN/PALO SECO
M5	ARTIFICIAL ISLAND
M6	DEEP WATER SITE

Based on the deliberations of the Workshop participants and the modifications to the listing of candidate sites as noted above, the 17 sites listed in Table 3-1 and shown in Figure 3-2 were selected for evaluation in this study.

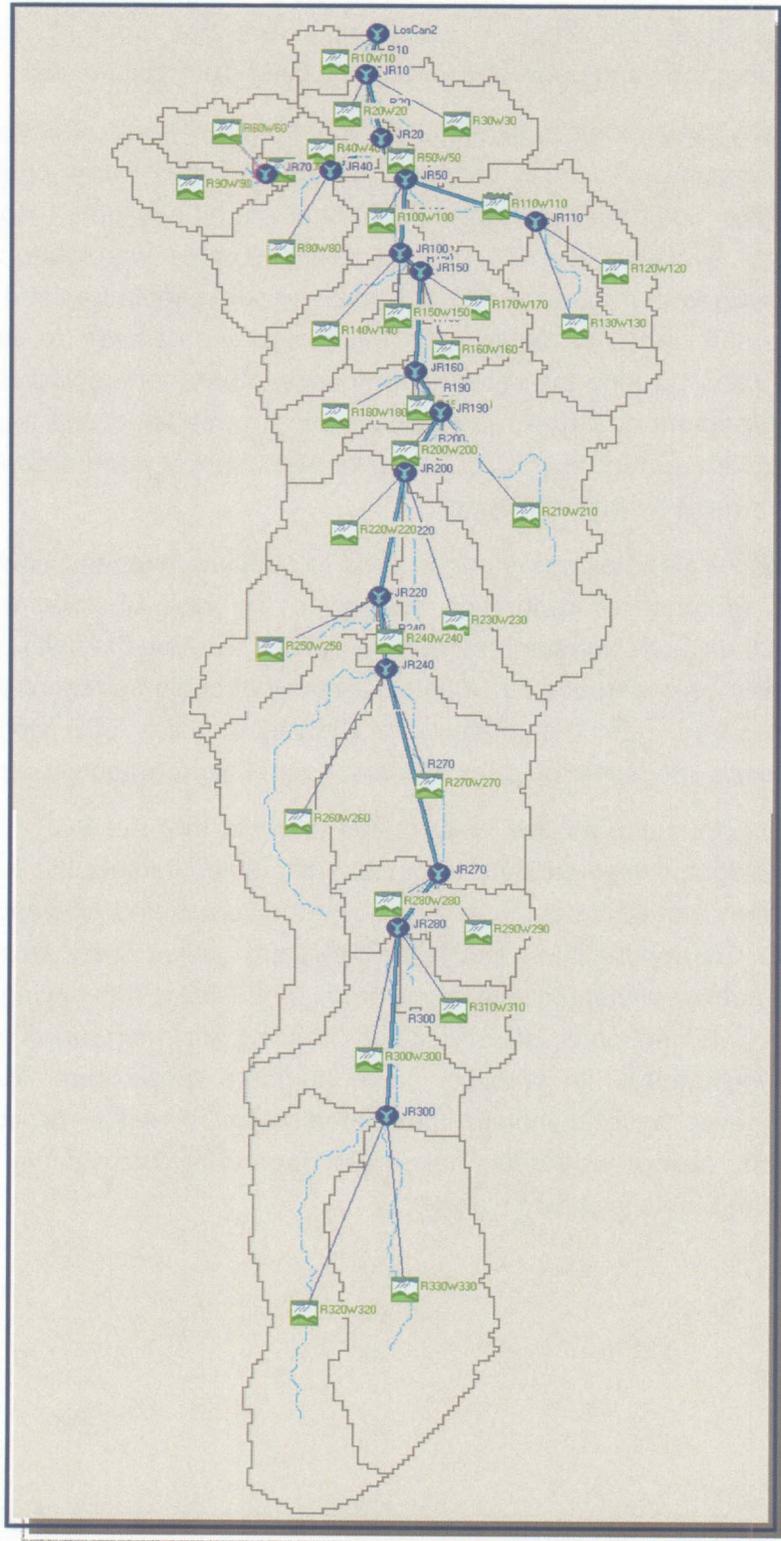
Figure 5-10: HEC-HMS Model Schematic for Los Cañones Watershed

Rainfall gage data was then collected for the nearby Jagua, Gasparilla, and Cañones gages and weighted to the different sub-basins using HEC-HMS inverse distance weighting techniques. General, approximate stream characteristics (channel slope, bottom width, side slopes, Manning's 'n' roughness) were also input into the HEC-HMS model from the topography and general knowledge gained from the site visit.

HEC-HMS has many sub models to simulate the runoff, tree-canopy interception, and soil loss infiltration processes. A simple constant rate model, SCS Curve Number, Green-Ampt, and a complex Soil Moisture Accounting model are all available. However, given the paucity of data available and the lack of past calibrated watershed model being available, it was decided that the SCS Curve Number model should be used. This model has been widely used and only requires the input of one parameter to simulate these canopy and soil losses. During the calibration process, other methodologies were tested to see if better agreement could be reached between the modeled and measured data, and these tests confirmed that the SCS Curve Number method worked best in modeling the peak flow and overall hydrograph shape.

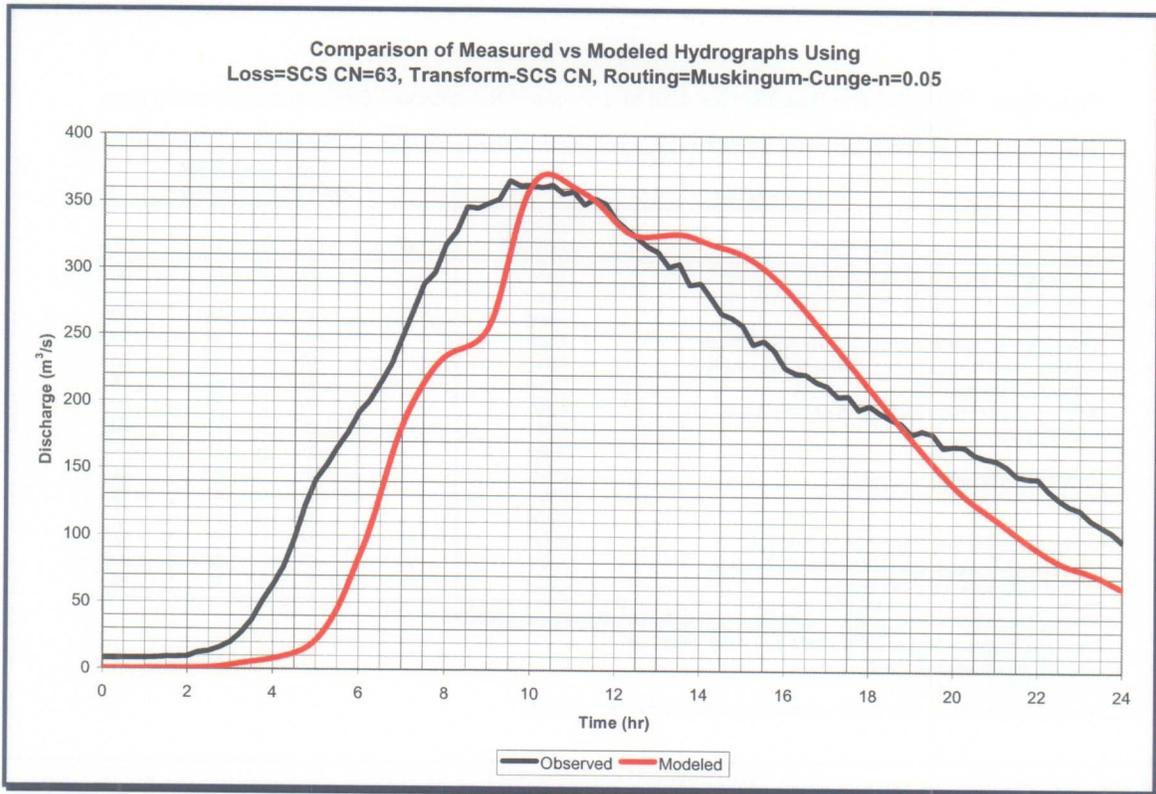
**Figure 5-11: Observed vs. Modeled Hydrograph for Los Cañones Watershed during November 2002 Storm**

With the model now calibrated for the curve number, this methodology and published literature values for curve numbers can be applied to other watershed areas in Panama with some degree of confidence. Therefore, for each terrestrial upland site, a HEC-HMS model will be created using the methodologies followed in the model calibration. Required model inputs include the design rainfall depths and distribution determined earlier, stream characteristics taken from the topographic mapping, and finally SCS curve numbers and unit hydrographs to determine design flows for which the drainage channels should be designed.

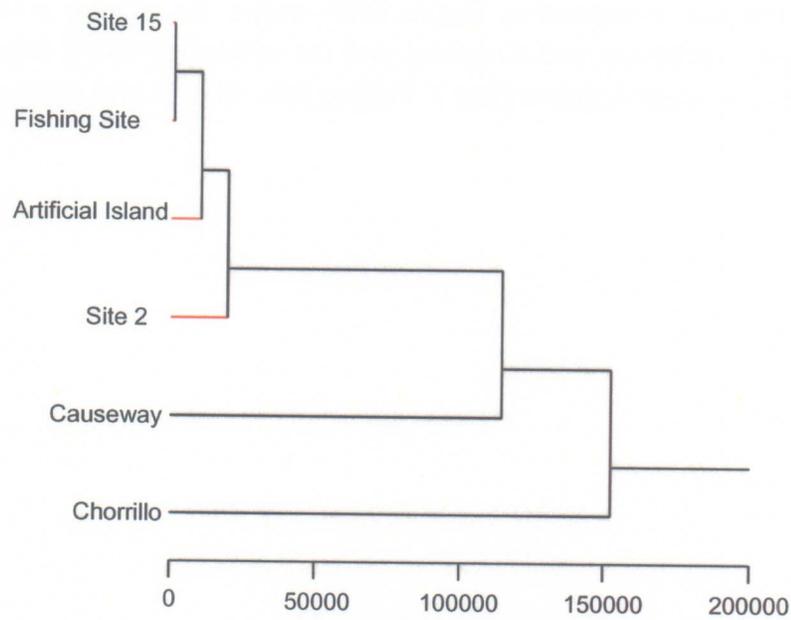
**Figure 5-19: Dendrogram for nocturnal collections**

(This is a multivariate analysis of Principle Components)

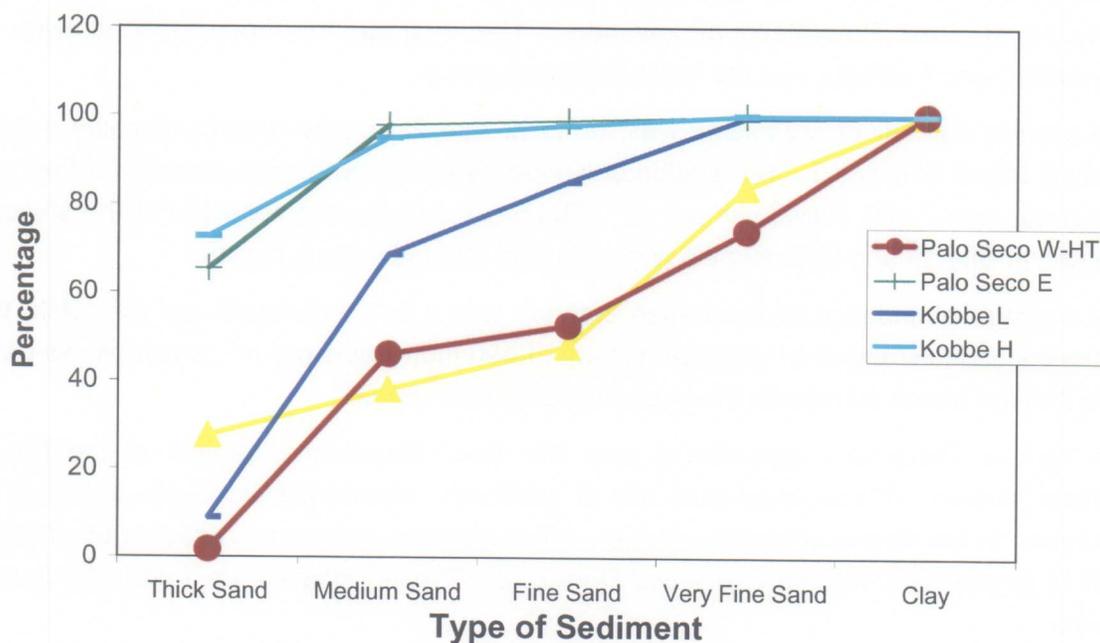
### Cumulative Curves

The method for the granulometric analysis was based on the Webthmore scale. Thick sand corresponds to grain size ranging 1.0 mm and 0.5 mm in size; medium sand 0.49 mm to 0.25 mm; fine sand 0.24 mm to 0.125 mm; very fine sand 0.124 mm to 0.062 mm; and clay particles smaller than 0.062 mm.

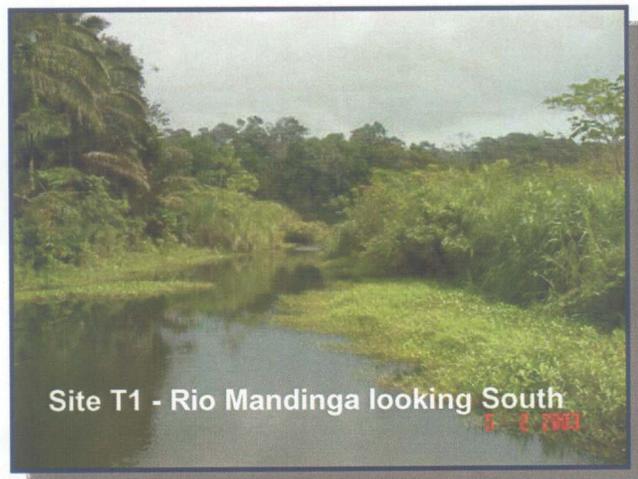
**Figure 6-2**  
**Watershed Delineation - Site T1**

The watershed area indicated in Figure 6-2 was calculated to be 4,010 hectares (40.10 km<sup>2</sup>). Using the design rainfall depth determined in the rainfall analysis and a number of watershed characteristics calculated from the existing topography, a HEC-HMS model was created to calculate the peak flow from the 100-yr, 24-hr storm. The methodologies used in the HEC-HMS model calibration, including the SCS Curve Number, SCS Unit Hydrograph, and the Muskingham-Cunge reach routing for simulating runoff were applied, where applicable, for this and all other individual site analyses.

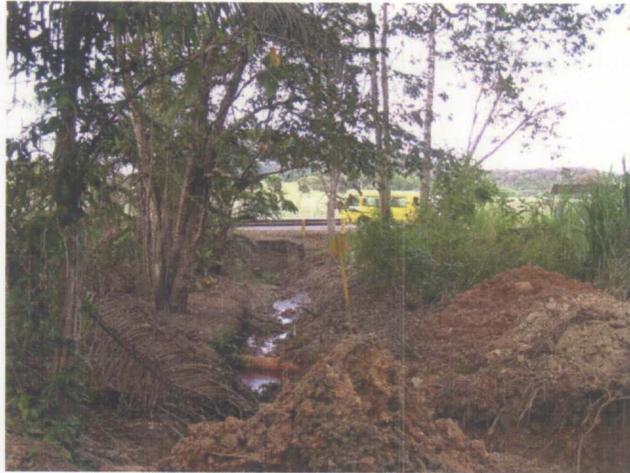
Drainage in this channel is poor and does not allow for a normal water flow during dry season.

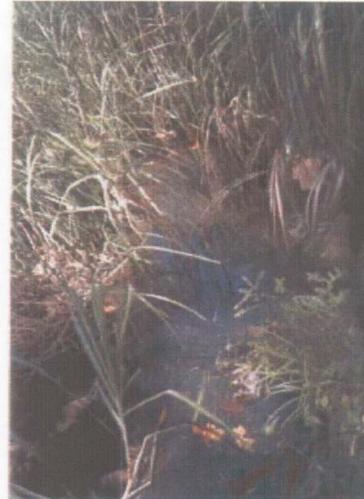
several transects. This was characterized by areas with high odor and showing high eutrophication levels caused by green algae, characteristic of stagnant waters.

Area of tributary containing contaminated stagnant waters

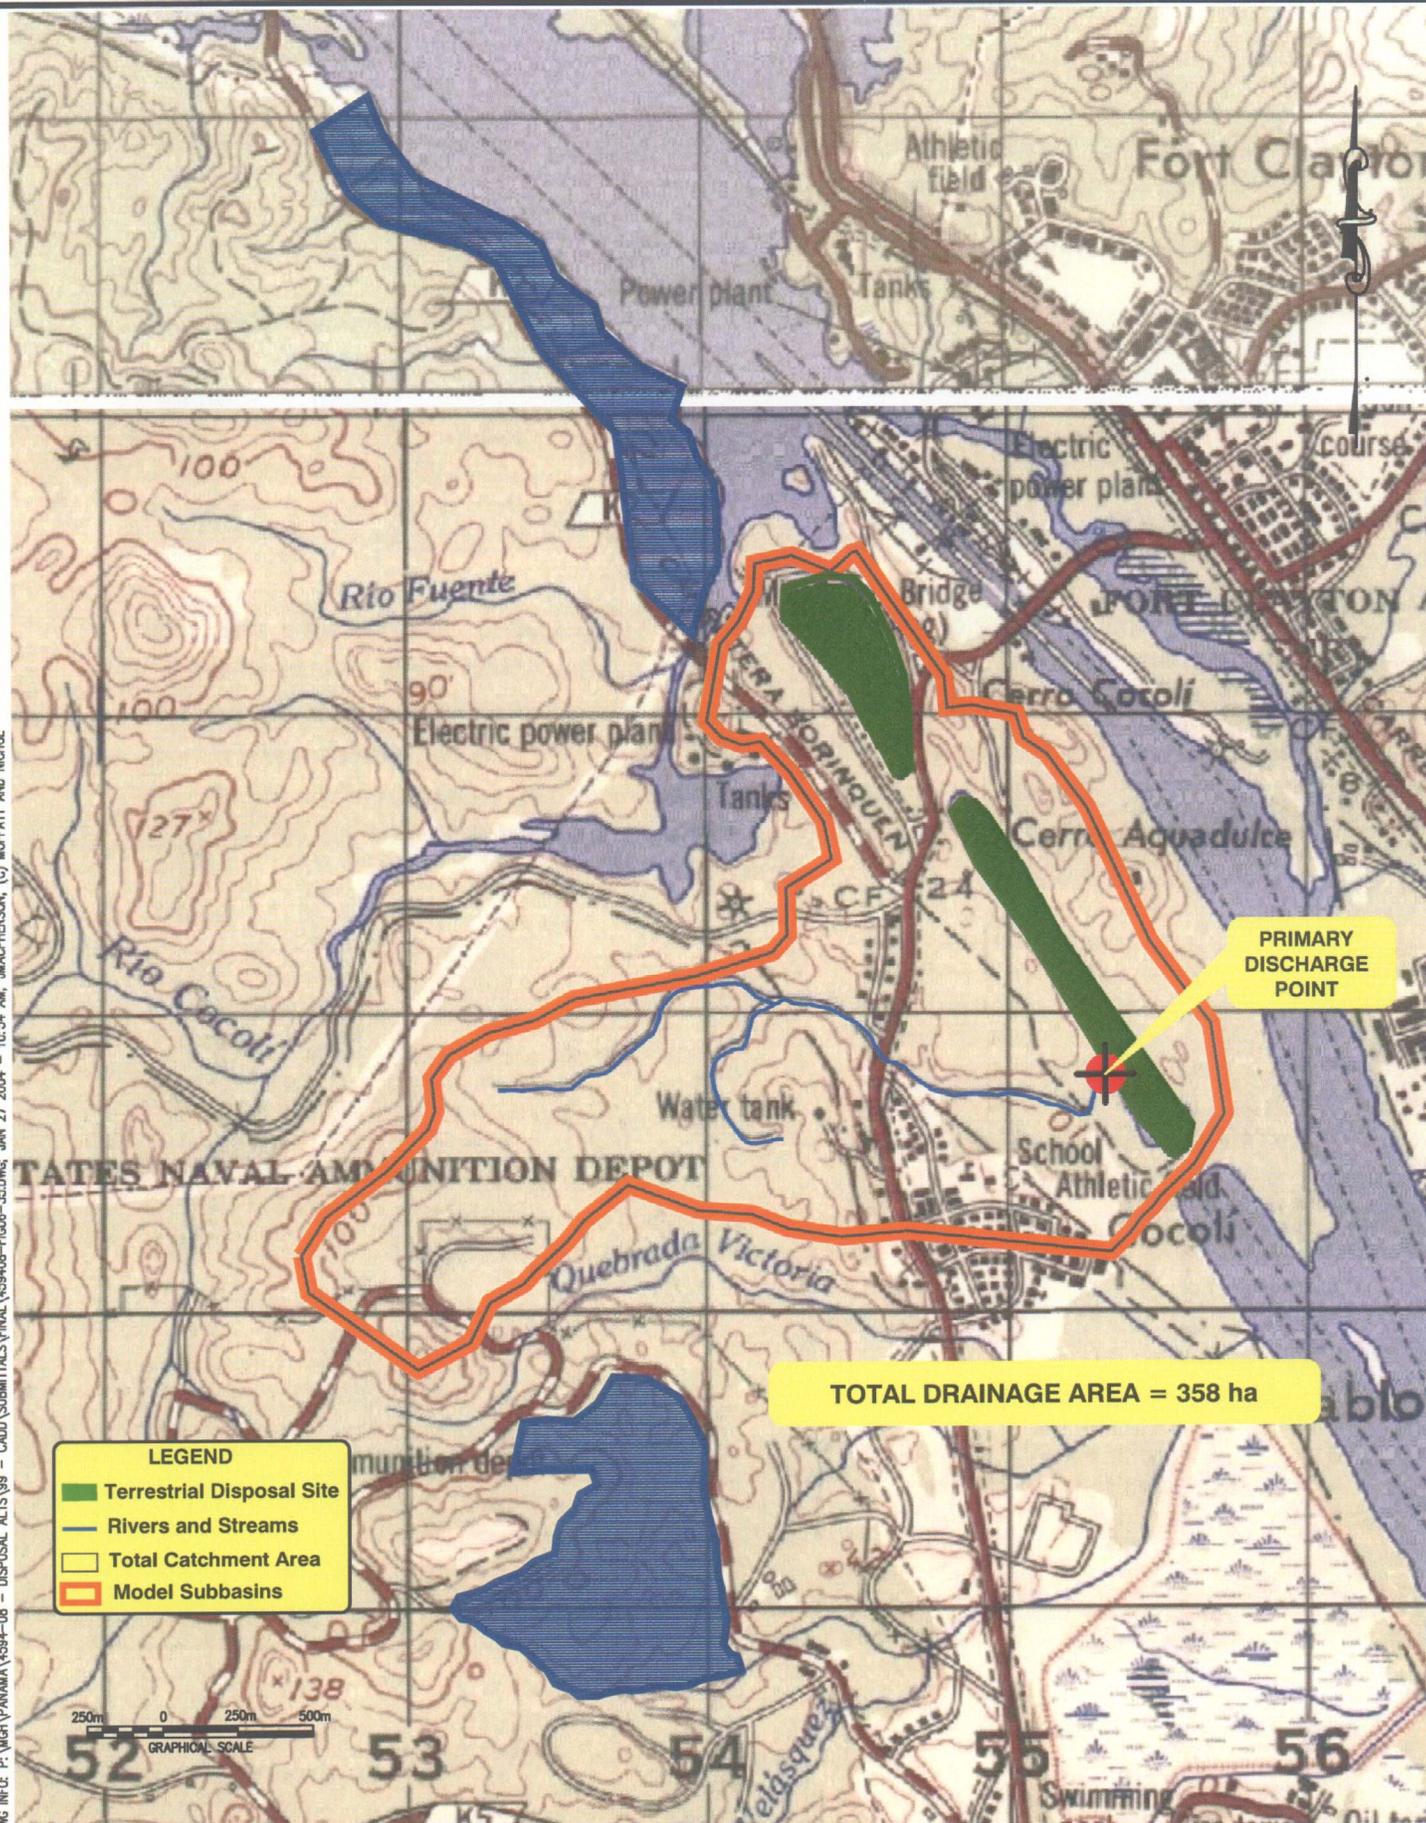
Figure 6-35  
Watershed Delineation - Site T8

The watershed area of this site includes the immediate surrounding area for the northern pond and a larger area expanding west around an unnamed tributary draining to the southern pond. As shown in Figure 6-35, the total area was calculated to be 358 hectares (3.78 km<sup>2</sup>). The land cover for this site is brush grassland, yielding an SCS Curve Number of 73. Using the design rainfall depth determined in the rainfall analysis and a number of watershed characteristics calculated from the existing topography, a HEC-HMS model was created to calculate the peak flow from the 100-yr, 24-hr storm. Given the

As can be seen in Table 6-13, the peak flow and required channel area and width calculated for the 100-yr, 24-hr event are manageable. Therefore, the creation of a diversion channel or channels along site boundaries or internal sub basin boundaries (depending on filling sequencing and/or ACP preference) of the site should pose no significant impediments. However, given the site's proximity to Canal waters, erosion and sediment control during filling will be especially important as to not divert sediments directly into the system that will eventually have to be dredged.

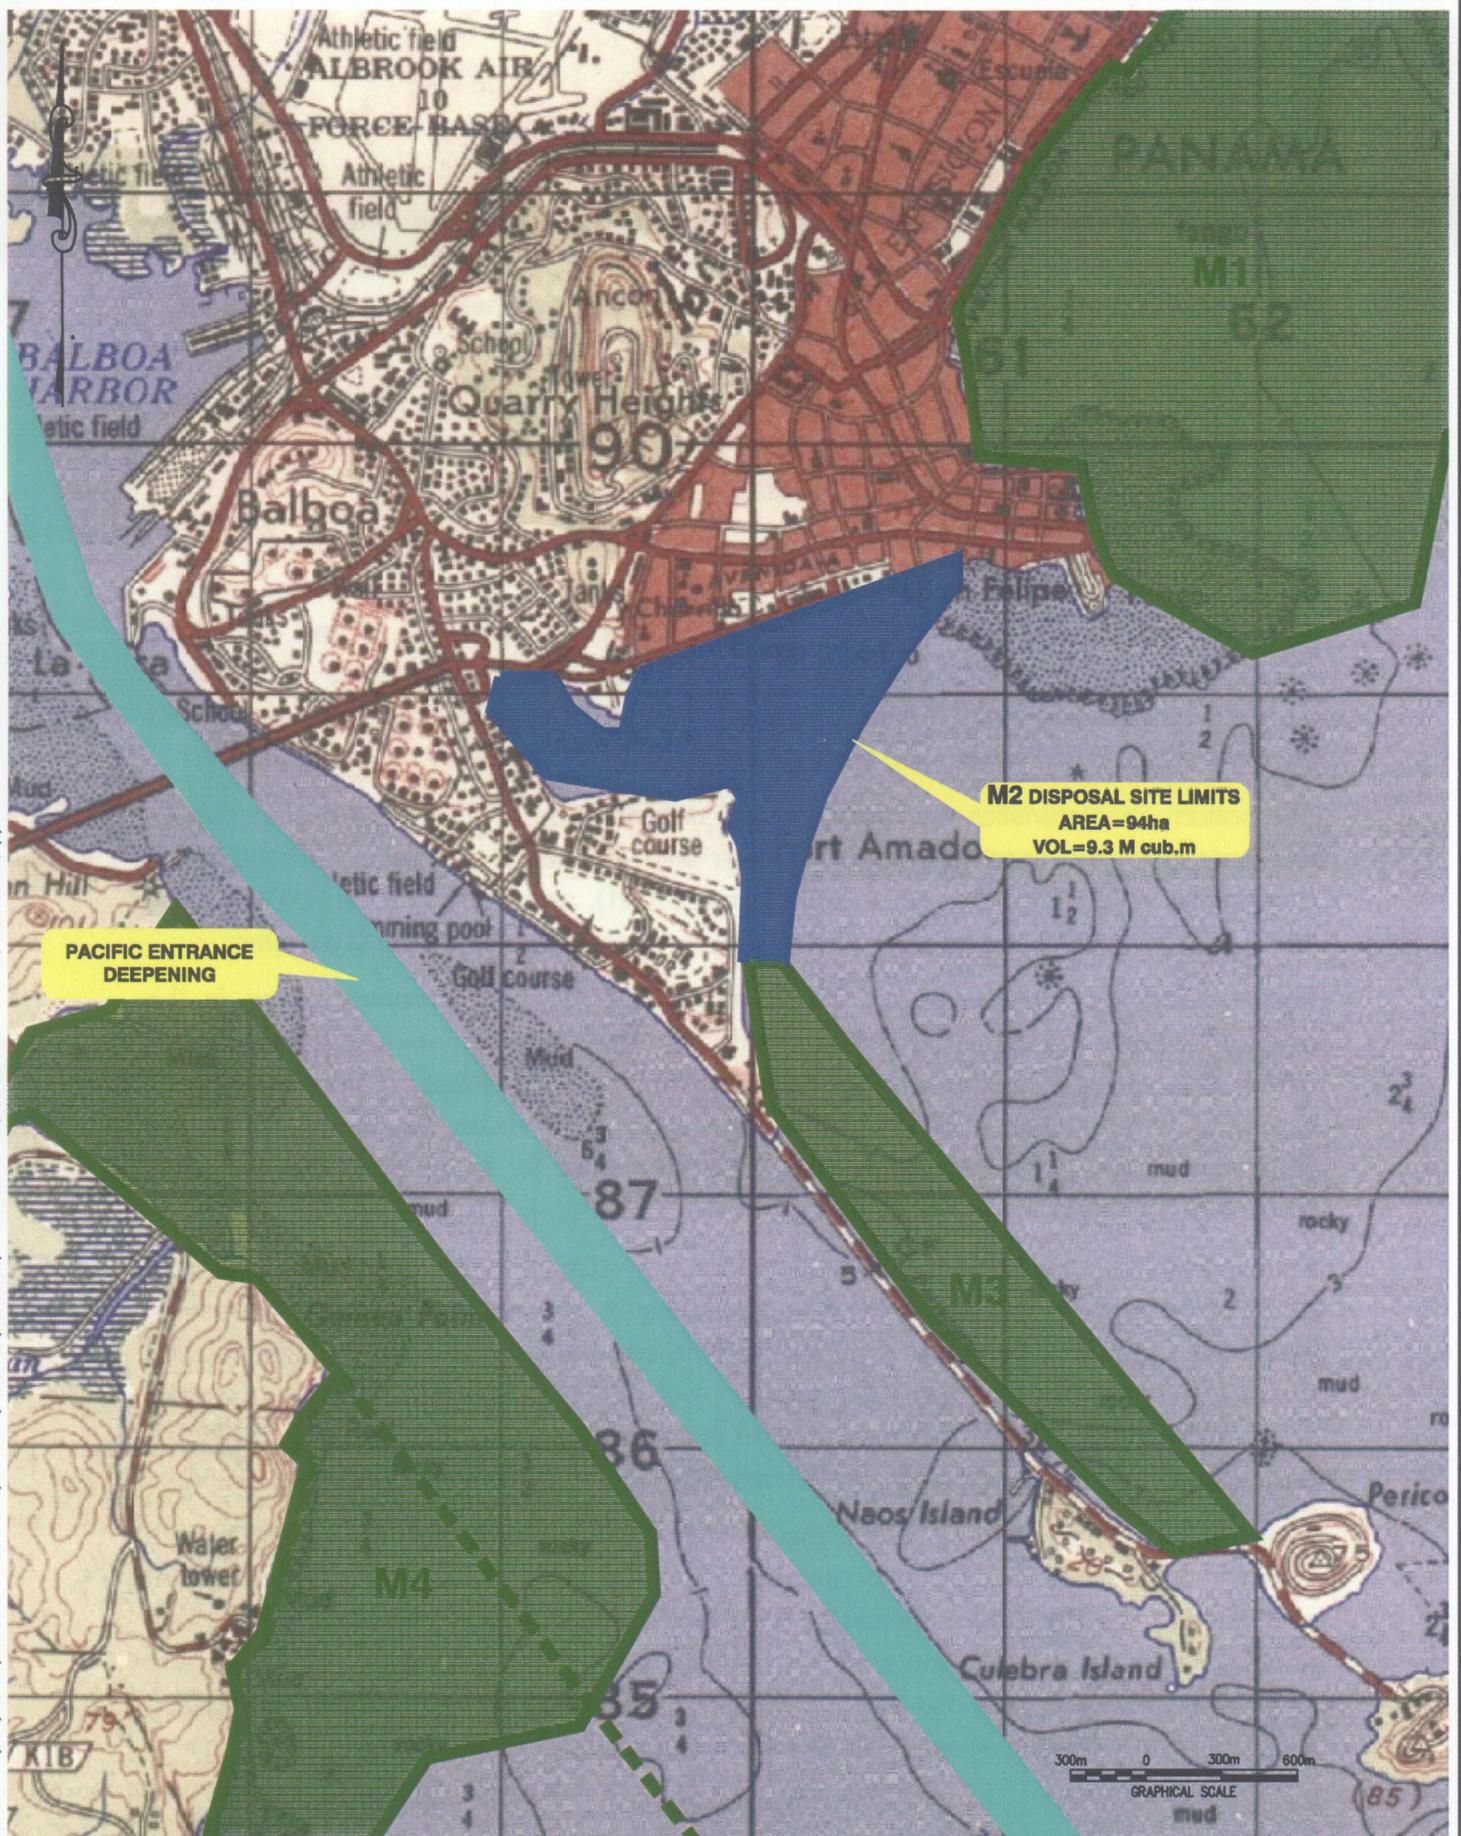
PACIFIC ENTRANCE DEEPENING

M2 DISPOSAL SITE LIMITS  
AREA=94ha  
VOL=9.3 M cub.m
