Panama Canal Commission  
Engineering Division  
Geotechnical Branch

THE RISK OF LANDSLIDES  
IN GAILLARD CUT

Luis D. Alfaro

October 20, 1988

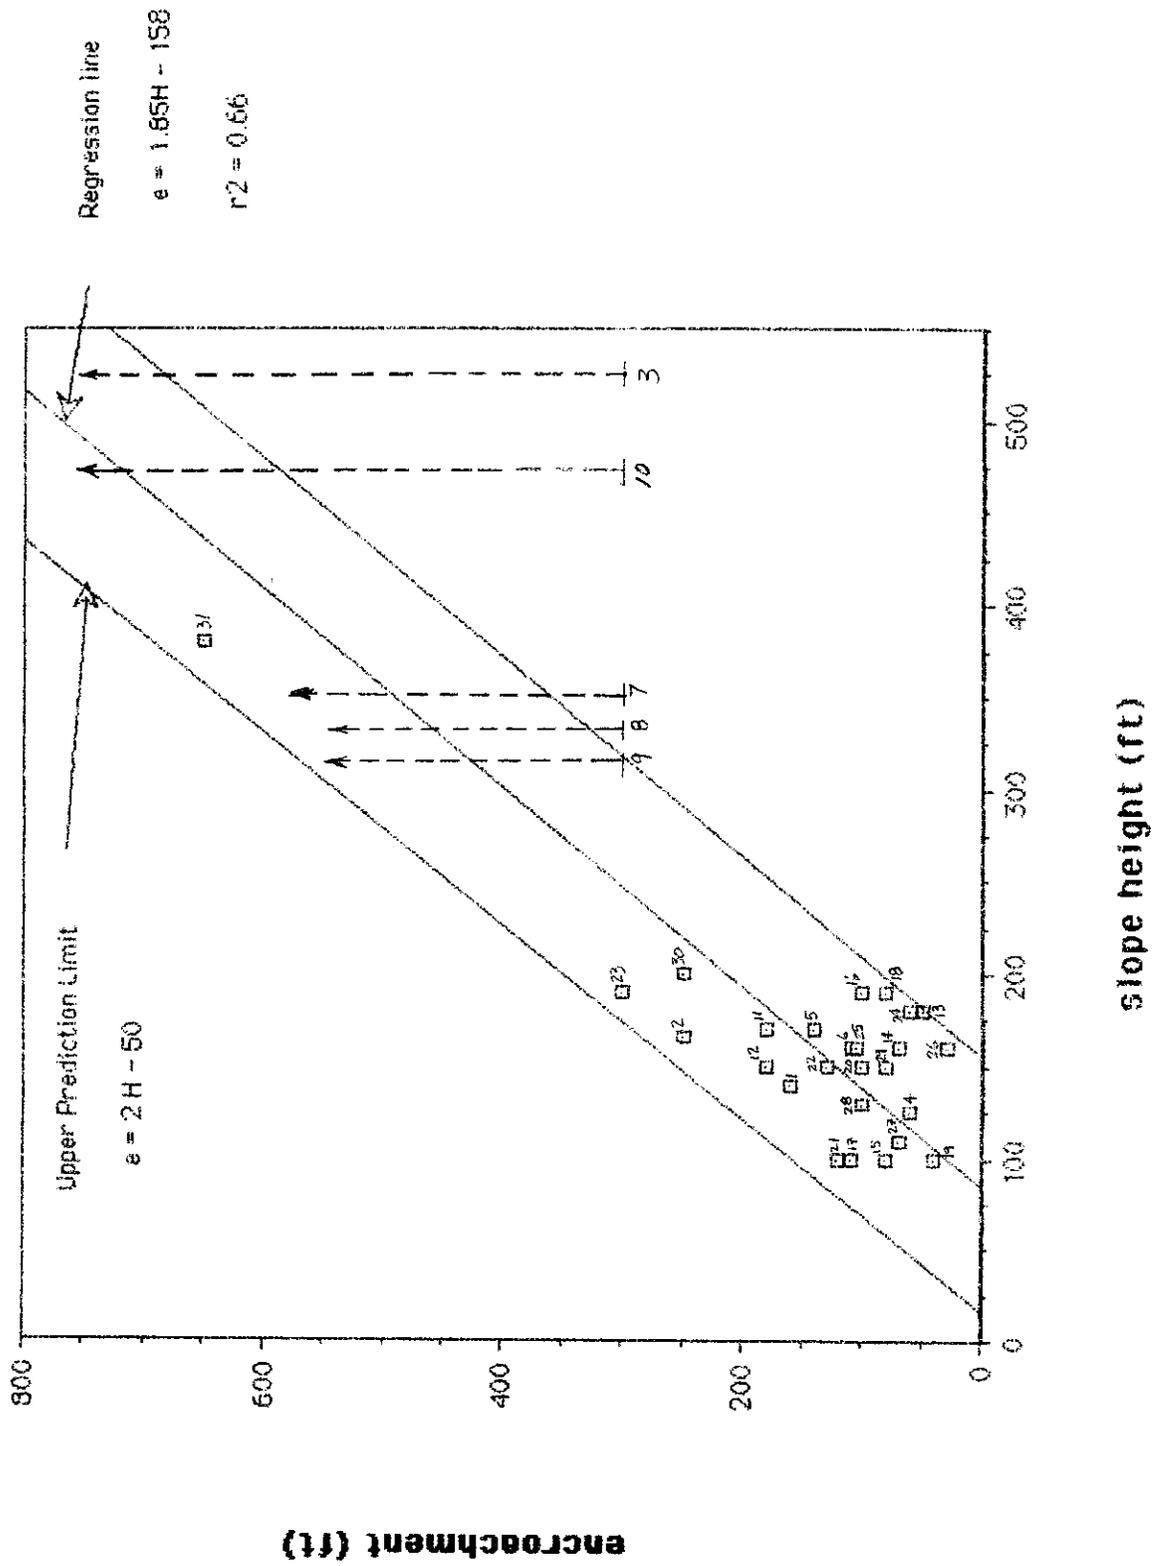
**Figure 4: Channel Encroachment vs Slope Height**

Figures 4 and 5 present these relationships. Although both have approximately the same correlation coefficient, the correlation with slope height is probably more useful because this variable involves less uncertainty than the length of the sliding mass. However, in some cases the length of the sliding mass may be relatively well defined. This information could come from previous sliding of the

We performed regression analyses to quantify the confidence that can be placed on these predictions. Figures 4 and 5 show the 90% confidence intervals on the predictions. The higher limit in each case offers a conservative upper bound on the amount of expected encroachment in case of a slide. These values can be represented by the following relationships:

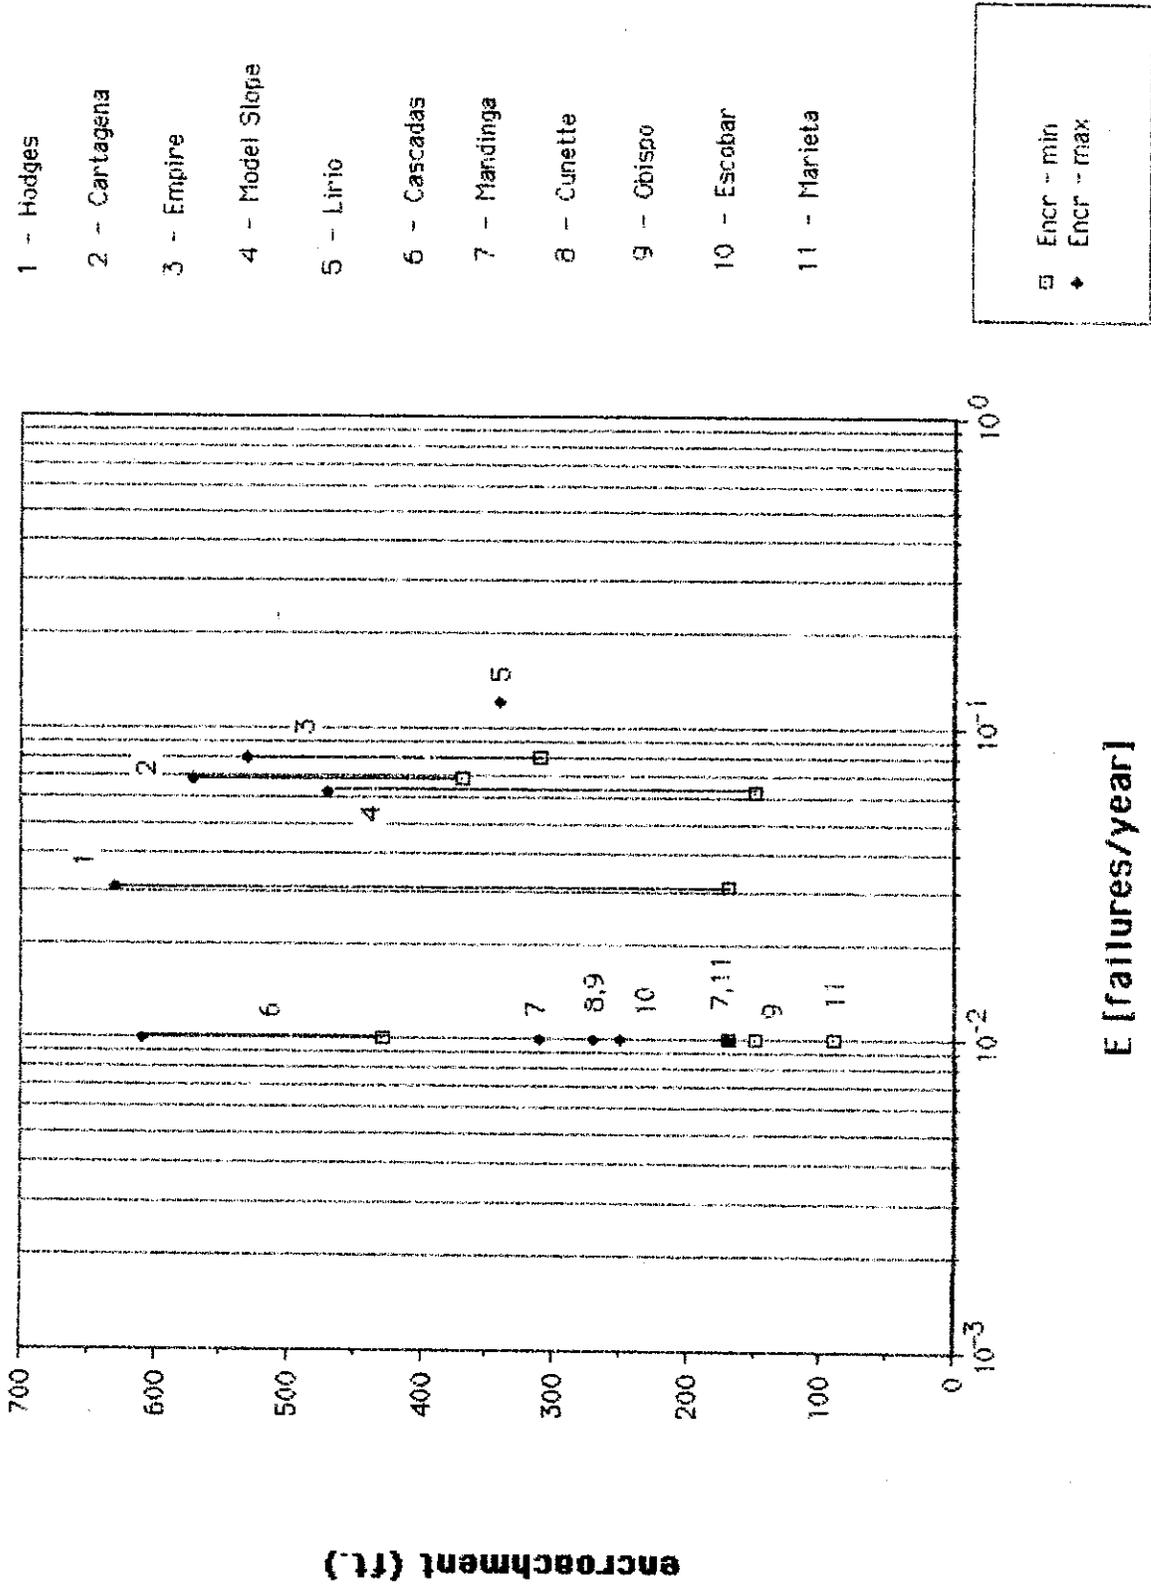
Figure 17: Comparison of West Bank Zones

Figures 16 and 17 present a comparison of the the potential for channel encroachments due to landslides in each zone. By plotting the estimated probabilities of failure (of manifesting instability) v.s. the (range of) potential encroachments for each zone, the zones that present the greatest danger of hindering or blocking navigation are easily detected. The range of potential encroachments refers to the variety of encroachments which can occur in a given zone due to variations in conditions within the zone. These are typically variations in slope height, the presence of igneous masses, etc.

As discussed previously, the Landslide Control Program effectively reduces the risk levels by approximately an order of magnitude. Still, the areas that present the largest probabilities of manifesting instabilities, and pose the greatest dangers of encroaching the navigation channel, are the ones we wish to see highlighted in this figure. Such information provides valuable guidance in the process of allocating advantageously the resources available for landslide control.

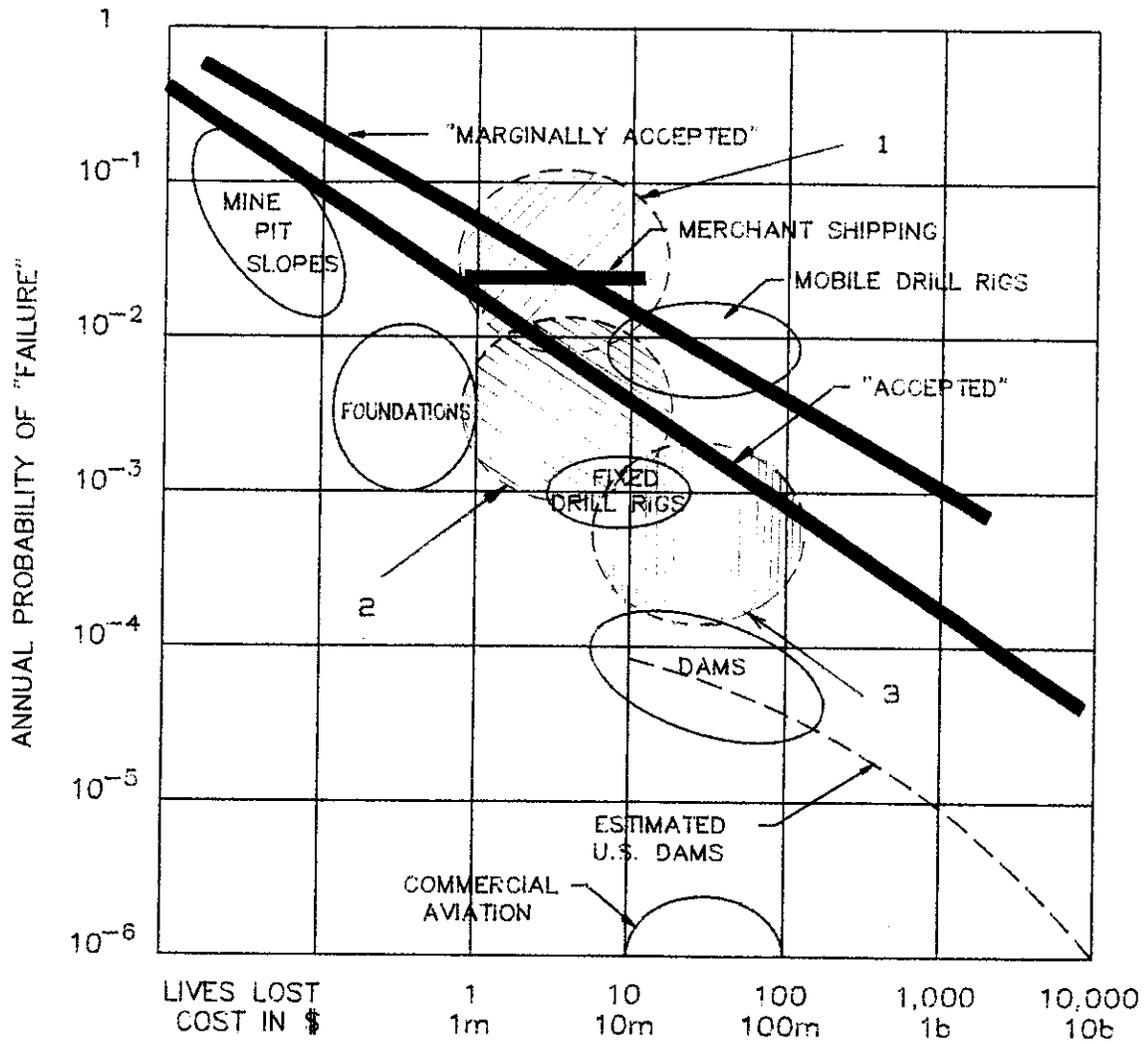
Figure 18: Risks for Selected Engineering Projects (Ref. 24)

Whitman (Ref. 24) has published criteria (proposed by Baecher) for assessing the probabilities of failure of slopes and other structures, based on past experiences. Figure 18 summarizes this information. We have added three additional items to this figure, for comparison purposes. These are:

1. The ranges applicable to the (tuffaceous) slopes in Gaillard Cut, when the probabilities that the slopes will manifest distress are used as the probabilities of failure (these would most likely be the probabilities of failure if no Landslide Control Program were available).
2. The ranges applicable to the same slopes, but using probabilities approximately an order of magnitude lower, due to the implementation of the Landslide Control Program.
3. The ranges applicable to the large igneous hills in Gaillard Cut.

The costs are rough estimates based on the cost of the 1986 Cucaracha Landslide. The risks were discussed in Section II.D of this Report. The impact of the Landslide Control Program is evident.

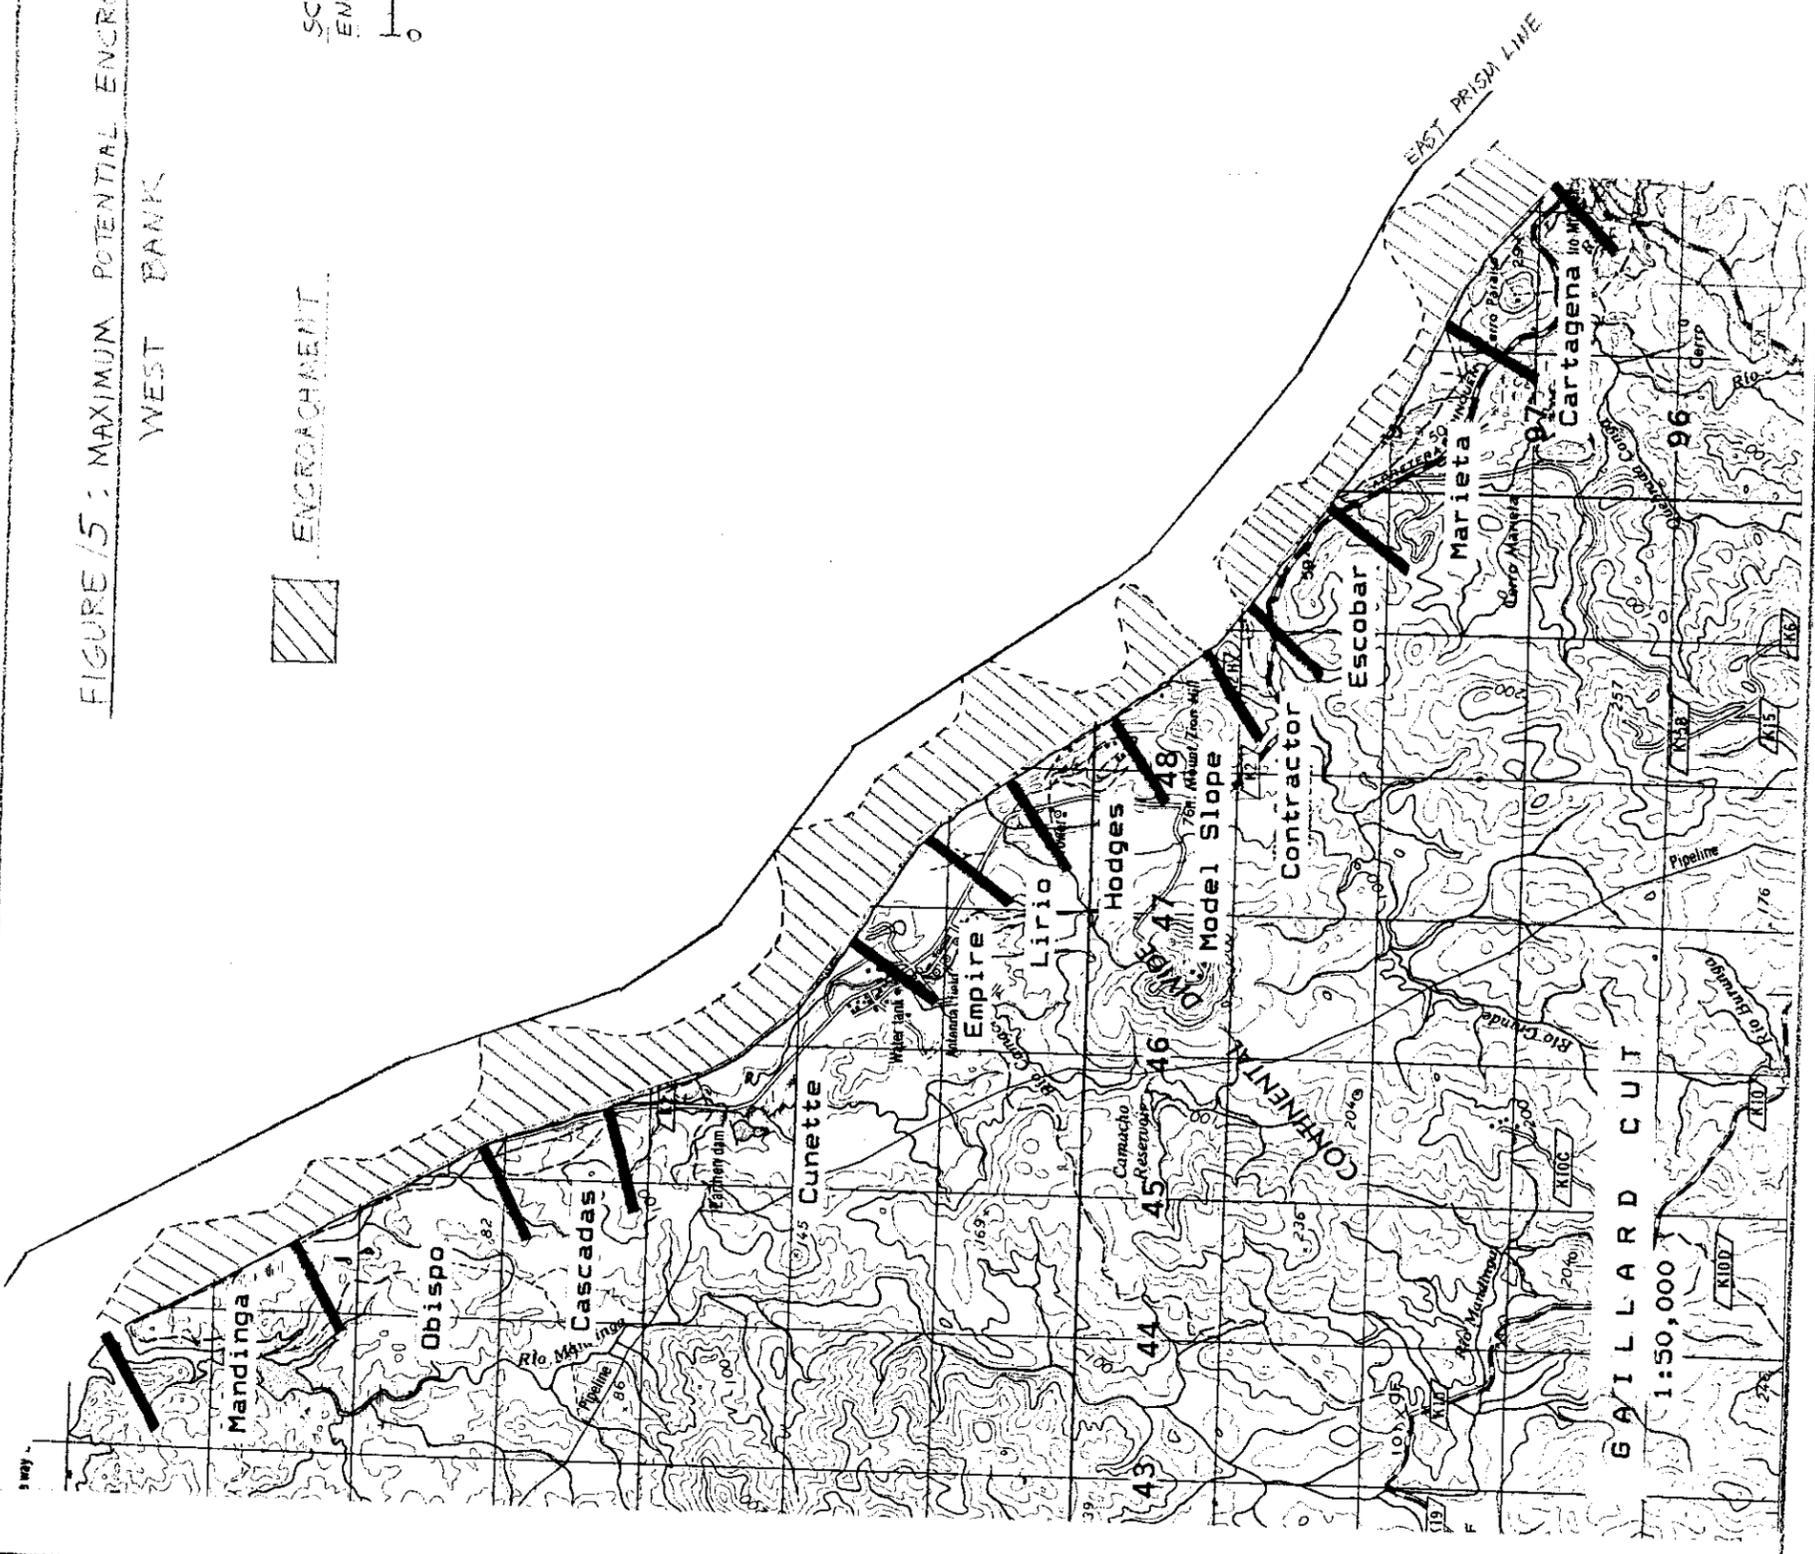
FIGURE 5: MAXIMUM POTENTIAL ENCROACHMENTS  
WEST BANK

Table 5 presents a prediction of the greatest potential encroachments in each bank. These are not expected encroachments; just the maximum values predicted by the analysis presented in Section II.C of this report. The regression line in Figures 4 and 5 coincide reasonably well with the criteria proposed by Binger in 1946. However, the upper prediction limits (which are effectively upper bounds to all the observed data contained in Table 3), were used to generate the conservative values of encroachments shown in Table 5. Figures 14 and 15 present a graphic representation of these maximum encroachments in the East and West Banks respectively.
