Panama Canal Authority
Engineering and Projects Department
Engineering Division
Geotechnical Branch

**Study on the effect of deepening
on Gaillard Cut slopes**

Volume 1

April 2002

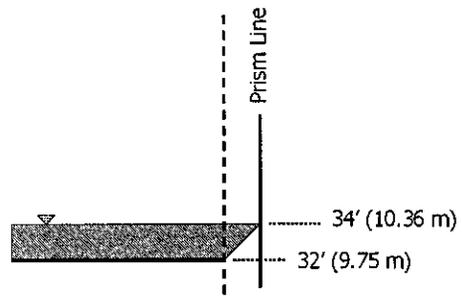
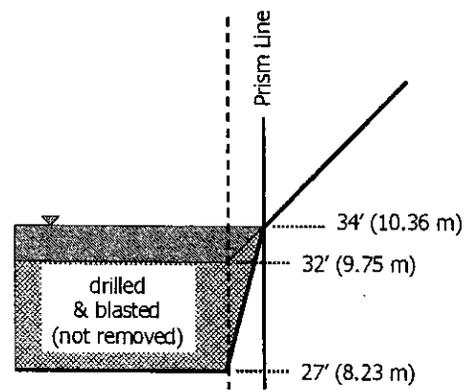
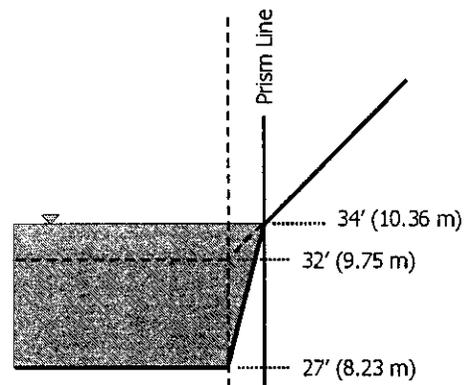
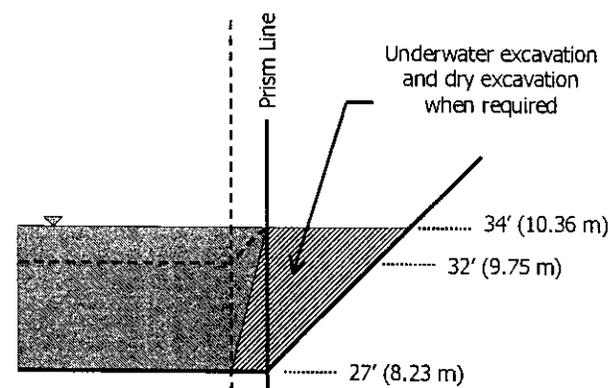
Figure 1a Design elevations for stability analysis and volume computation

Case 1 (Existing Condition)

Case 2 (Drilled & Blasted to Elev. 27')

Case 3 (Material removed to Elev. 27')

Case 4 (Design Excavation)

A new proposal to deepen the Gaillard Cut and Gatun Lake to lower elevations than 34' PLD (10.36m) has been suggested to accommodate future expansion of the Canal. To evaluate this proposal and the cost involved in deepening the Cut more than 3' (1.00m), stability analyses were performed for the following conditions (Figures 1a and 1b):

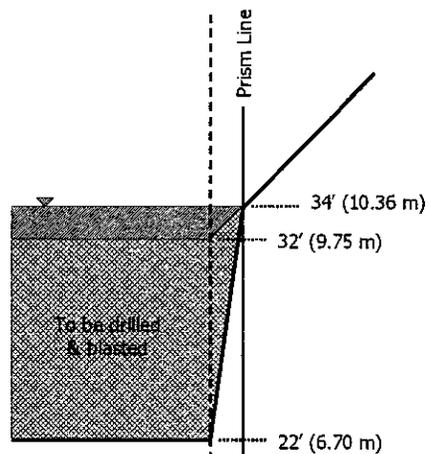
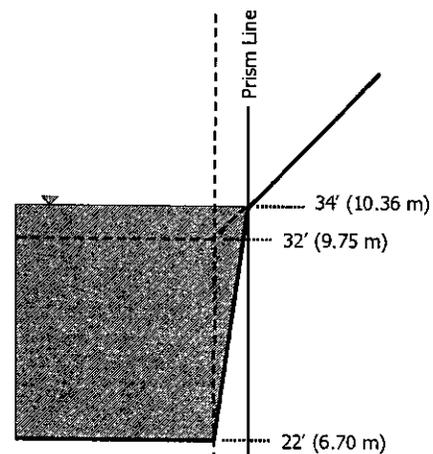
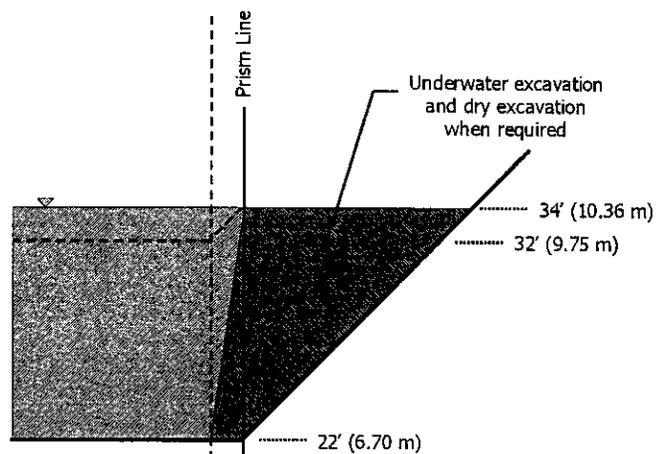
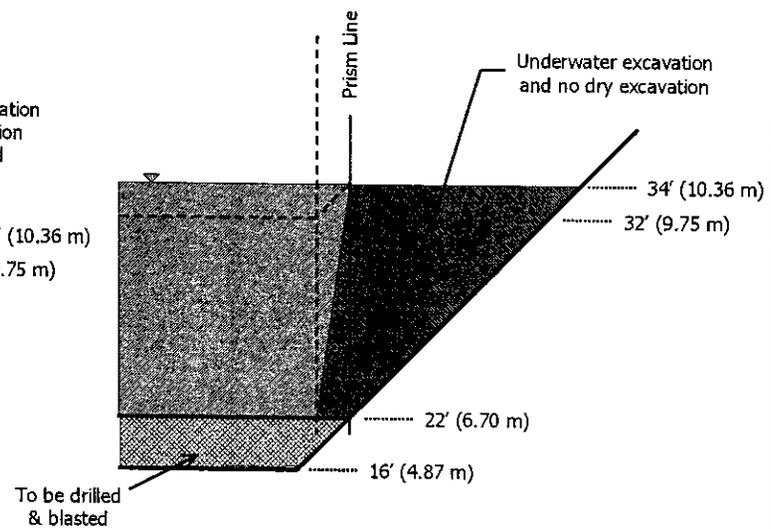
Figure 1b Design elevations for stability analysis and volume computation

Case 5 (Drilled & Blasted to Elev. 22')

Case 6 (Material removed to Elev. 22')

Case 7 (Design Excavation)

Case 8 (Blasted to Elev. 16')

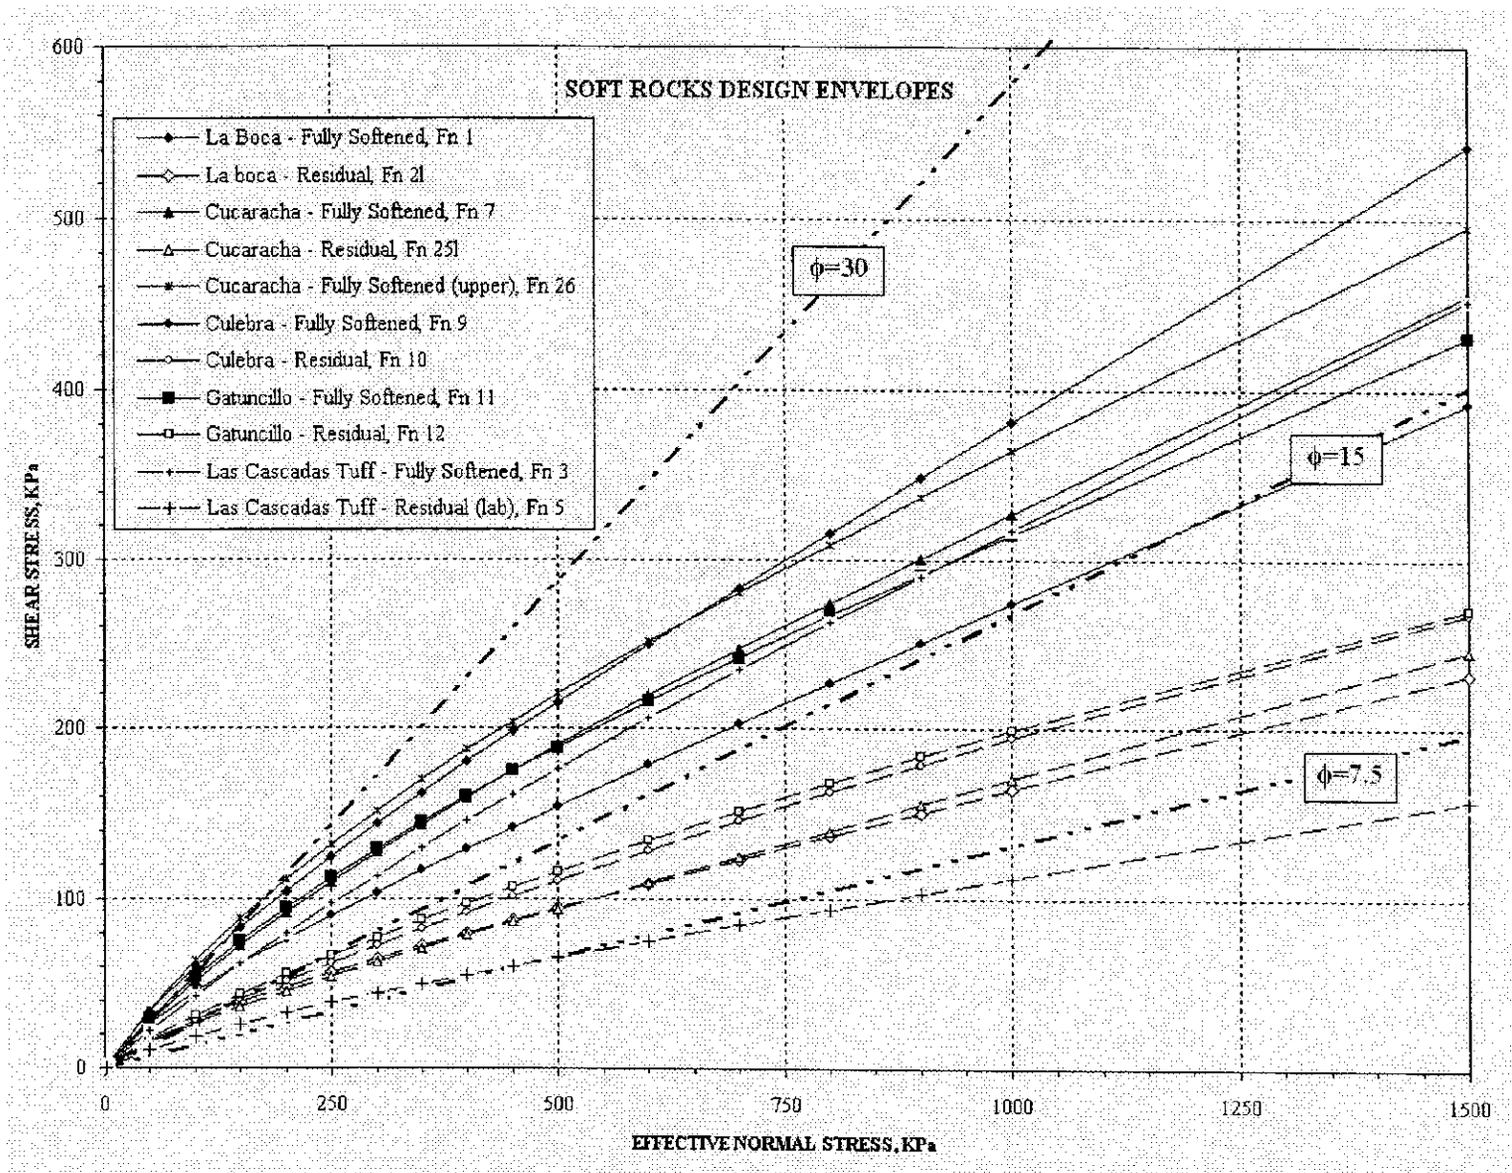
Figure 2a Soft Rocks Shear Strength Envelopes

Table 1 and Figure 2a summarizes these soft rock envelopes. Finally, all blasted materials in soft rocks were modeled using the residual shear strength envelope.

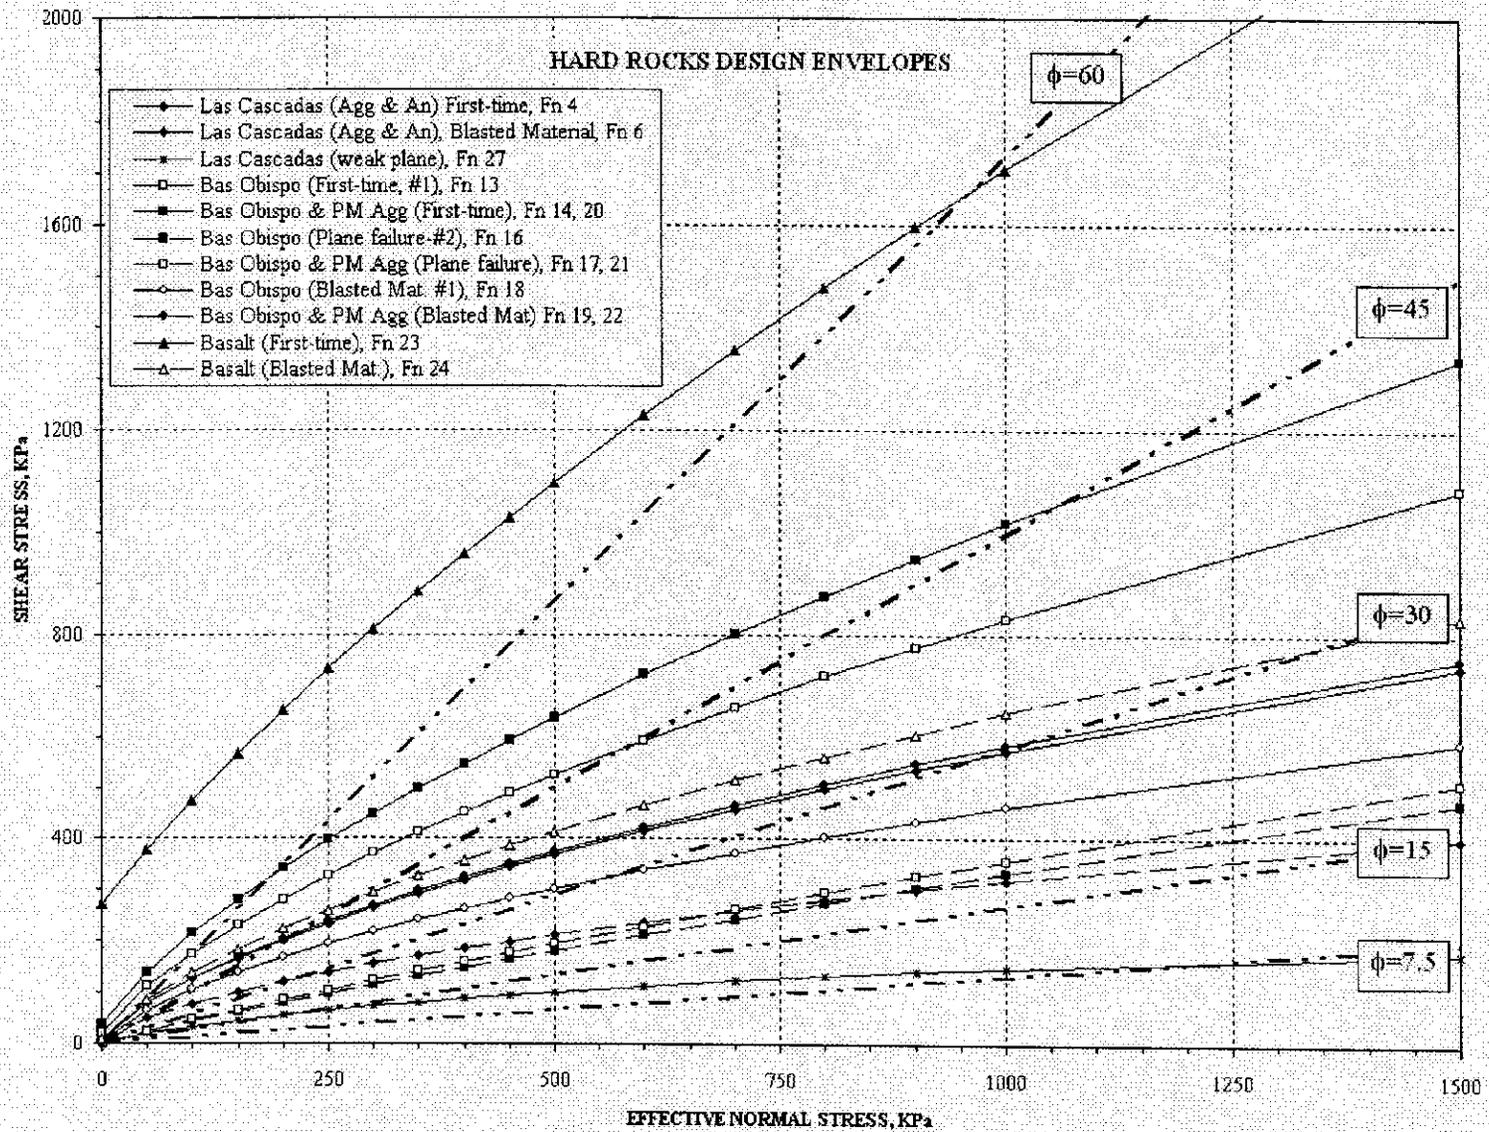
Figure 2b Hard Rocks Shear Strength Envelopes

The parameters ϕ_b , JRC and JCS are the base friction angle, joint roughness coefficient and joint wall compressive strength respectively. These parameters were empirically estimated from the back analysis of past failures. Table 1 and Figure 2b summarize the strength envelopes developed for this study. Finally, all blasted materials in hard rocks were modeled using the Hoek-Brown criterion for poor quality rock mass.

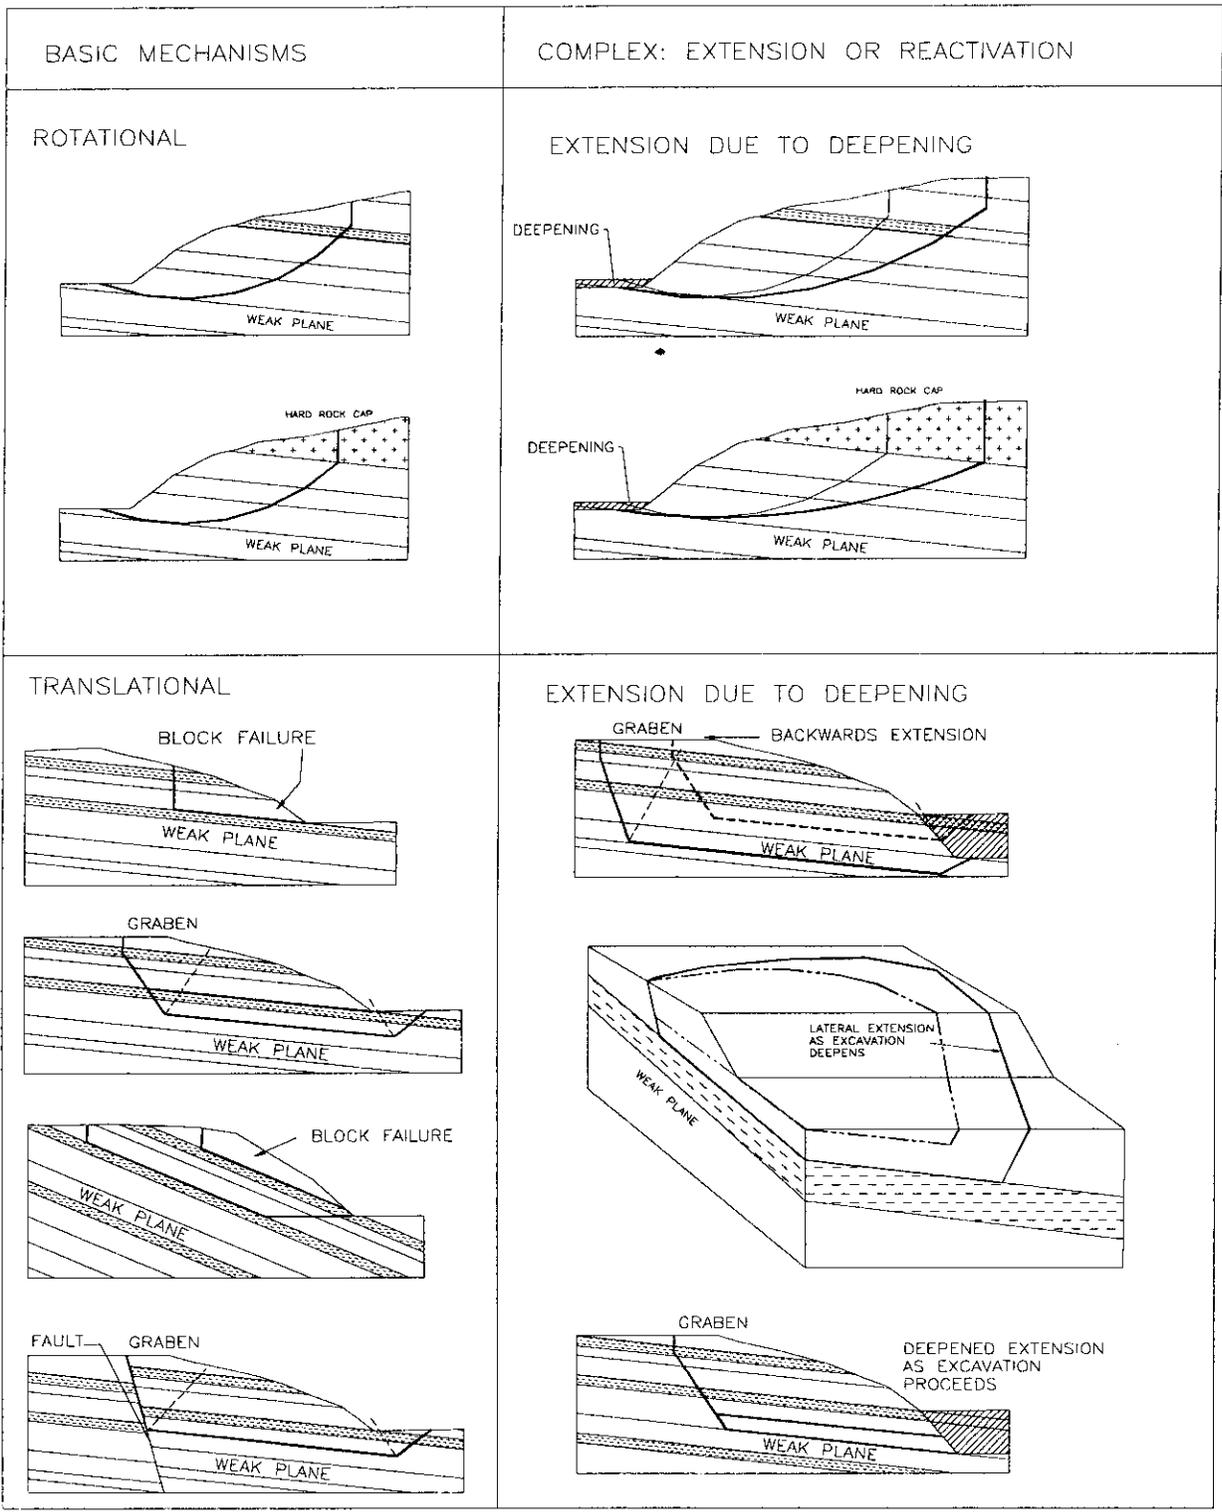
Figure 3 Assumed failure mechanisms as a function of structural setting

The structural controlled failure of many slides along Gaillard Cut is well recognized. Experience with past failures in the Gaillard Cut suggests that the probable failure geometry will be one of those described in Figure 3. Rotational failure will occur where bedding dips into the slope or

where the slope mass is closely jointed. Furthermore, a special case where a hard rock cap (see Figure 3) is present over soft rock at the head of the slope, the failure mechanism should include a large tension cracks in the stability analysis to avoid large negative (tension) interslice forces. Field evidence of this tension crack has been seen in Hodges Hill Slide and Contractor's Hill, for example.

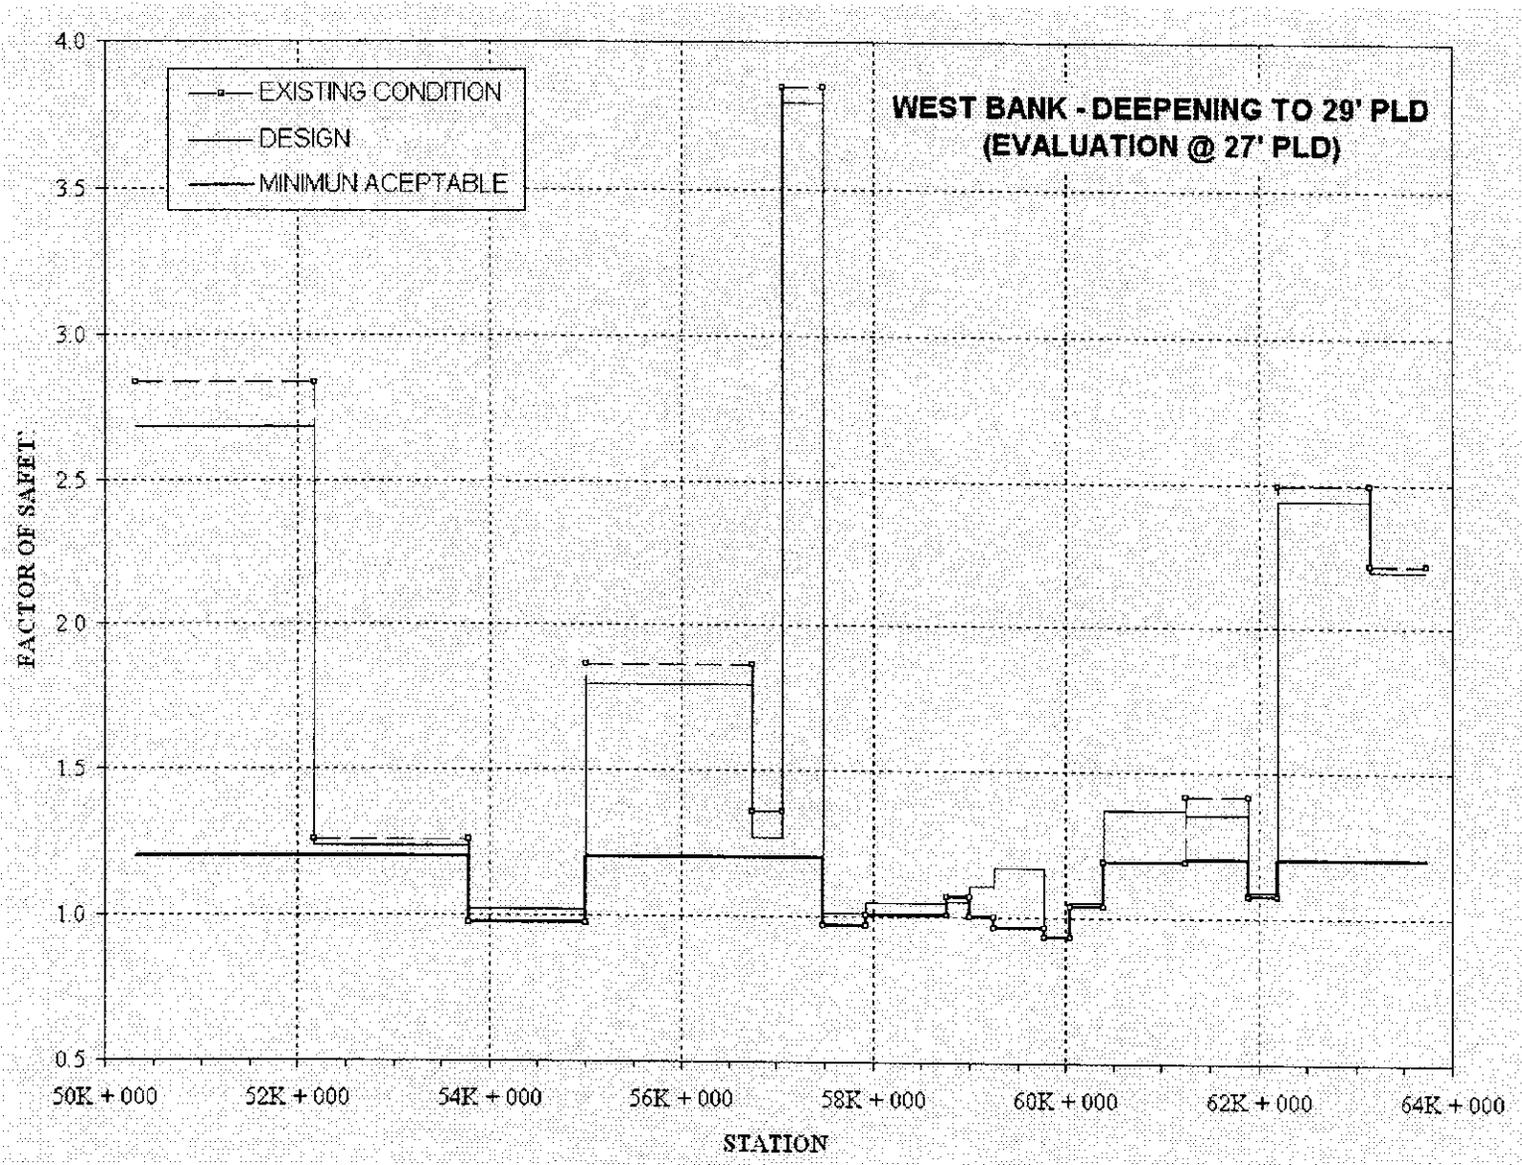
Figure 4a Results of stability analyses (West bank, elevation 27' PLD)

Tables 2 and 3, and Figures 4 and 5 summarize the results of the stability analysis performed on each representative station under various conditions (as specified above). Appendices A and B assemble a detailed report on the stability analyses carried out on the selected sections.

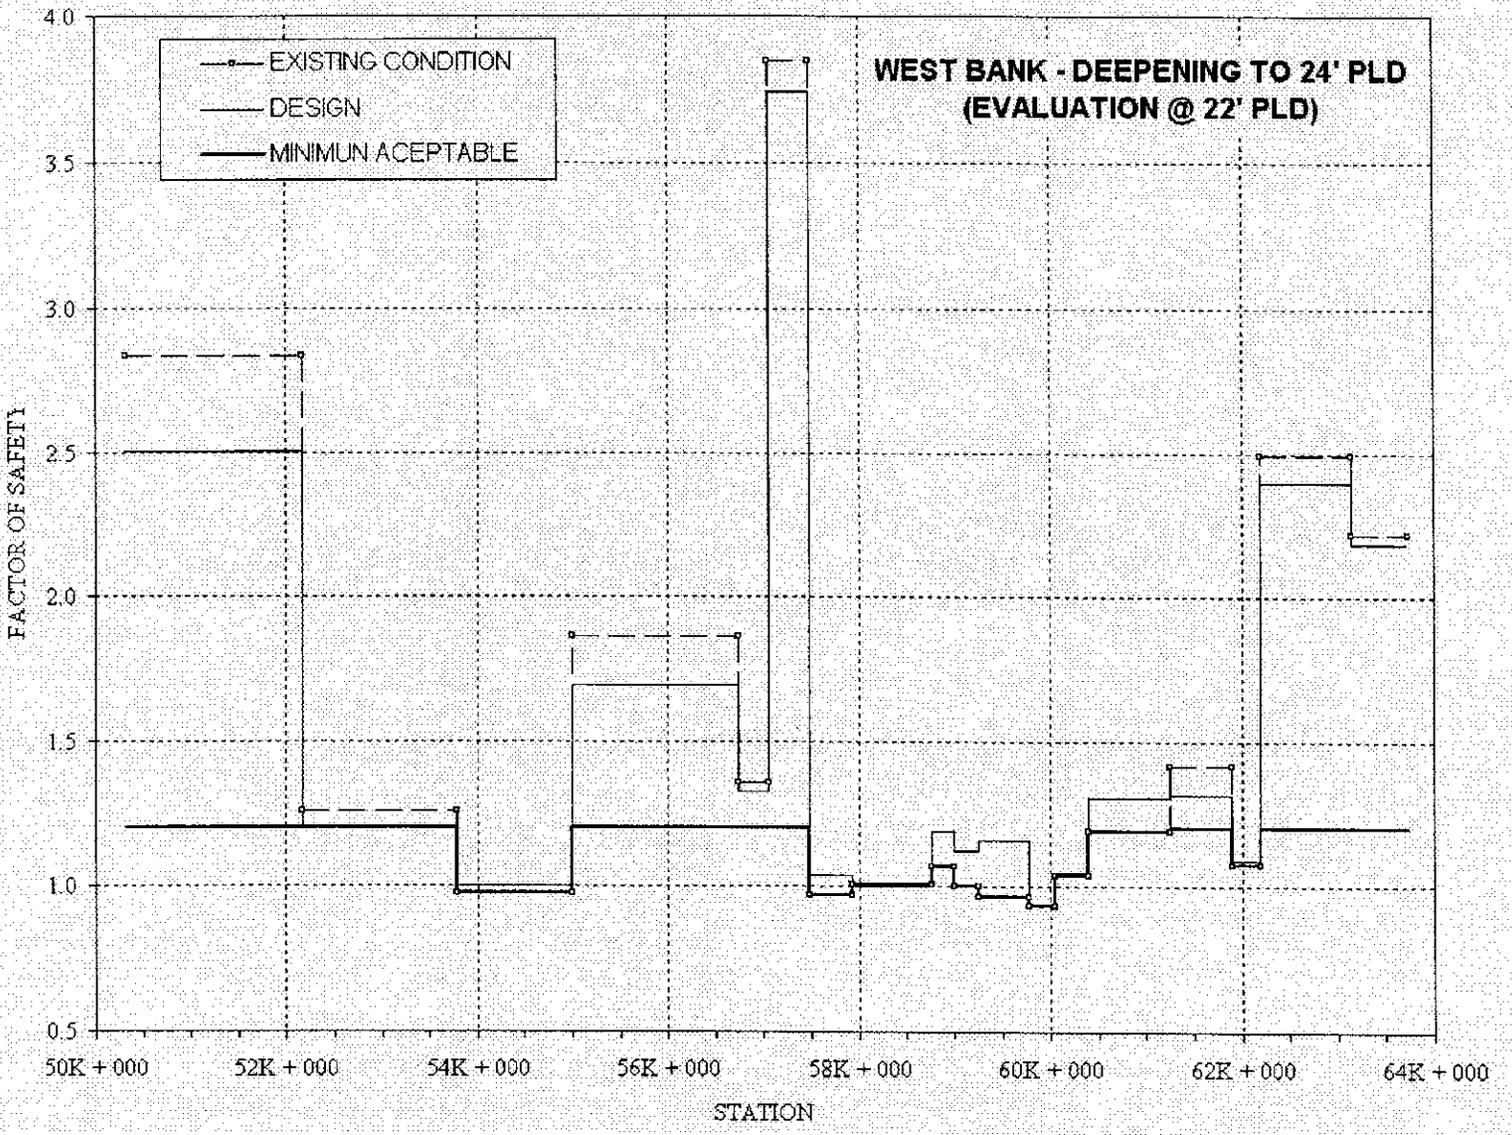
Figure 4b Results of stability analyses (West bank, elevation 22' PLD)

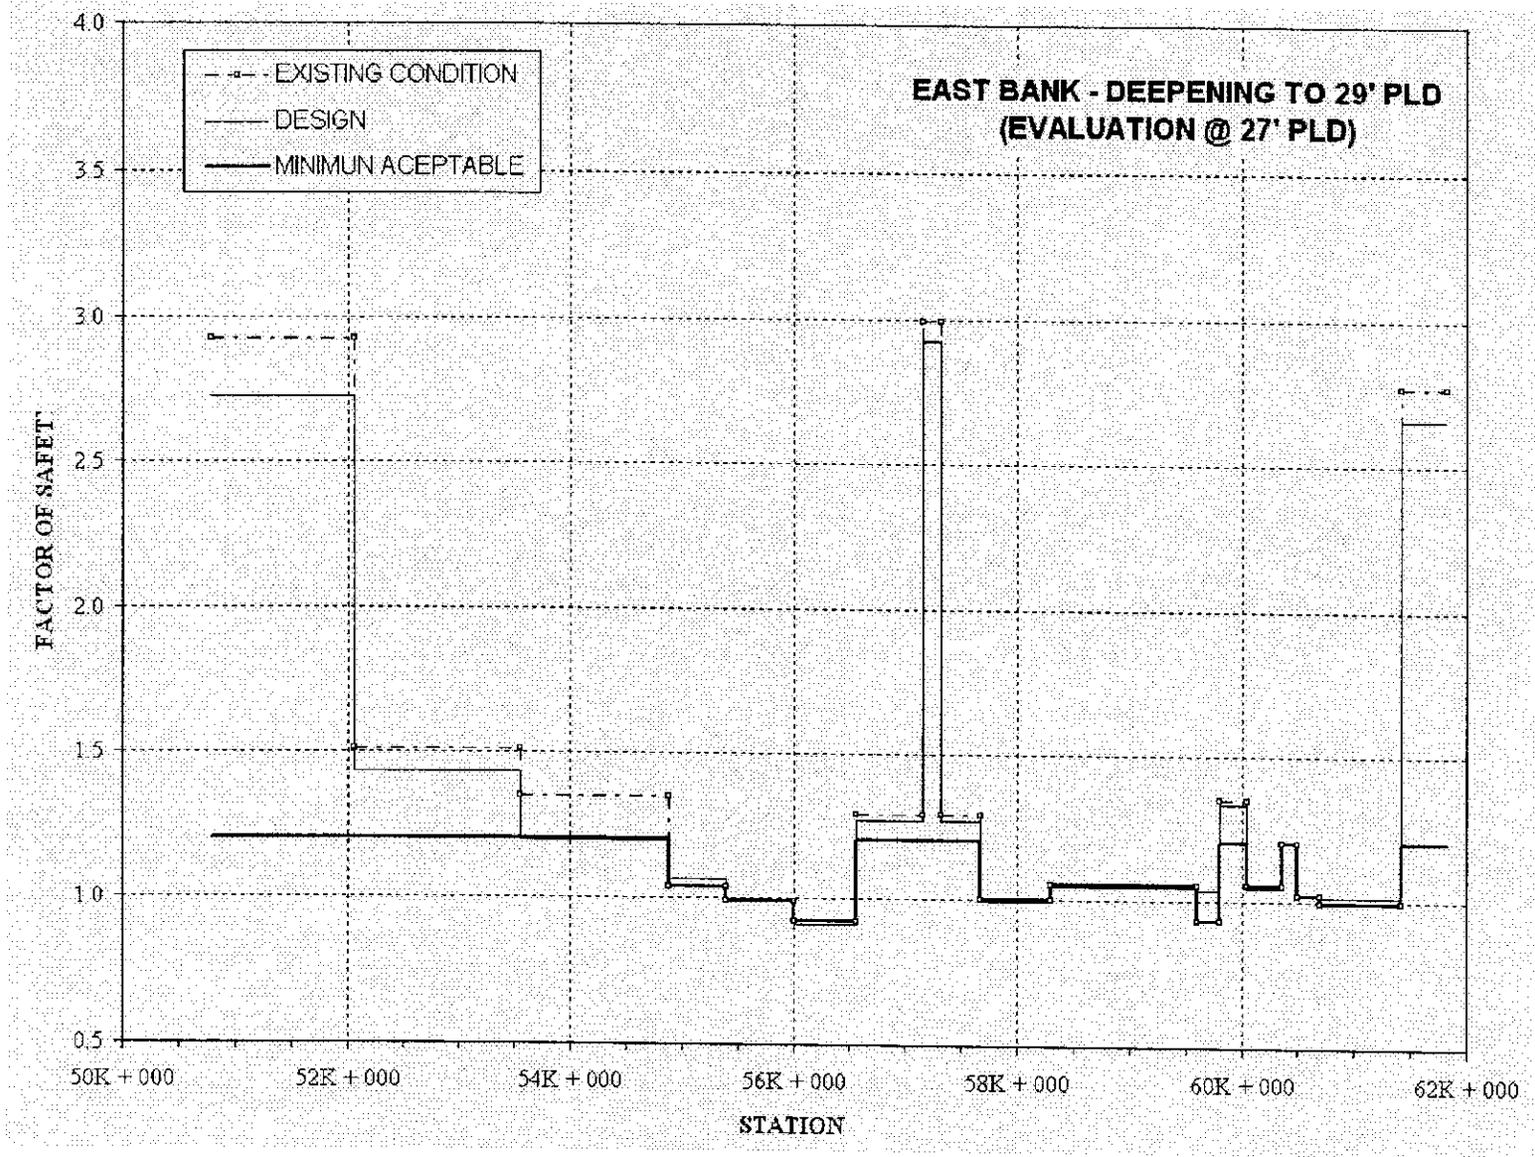
Figure 5a Results of stability analyses (East bank, elevation 27' PLD)

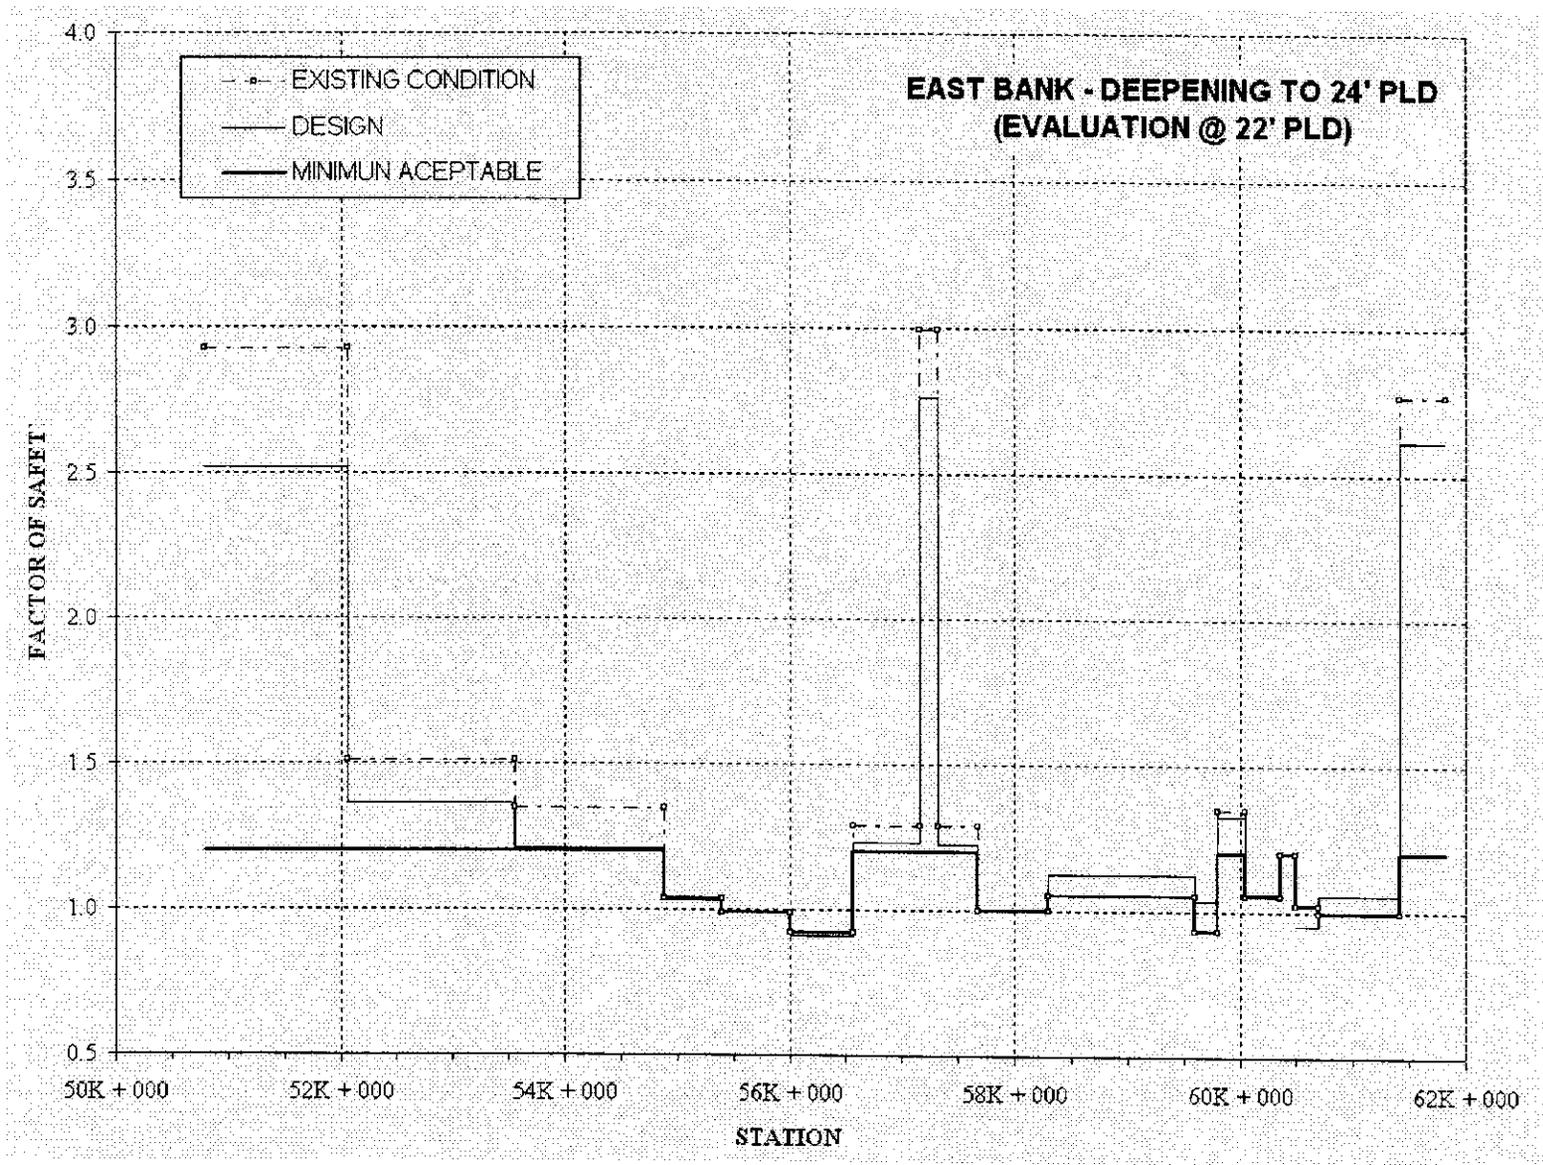
Figure 5b Results of stability analyses (East bank, elevation 22' PLD)
